Remington Model 710

.30-06 Caliber Bolt Action Rifle

Engineering Evaluation Report High Load Firing Pin Test

Remington Model 710, .30-06 Caliber Bolt Action Rifle
R & D Technical Center Project No. 241095

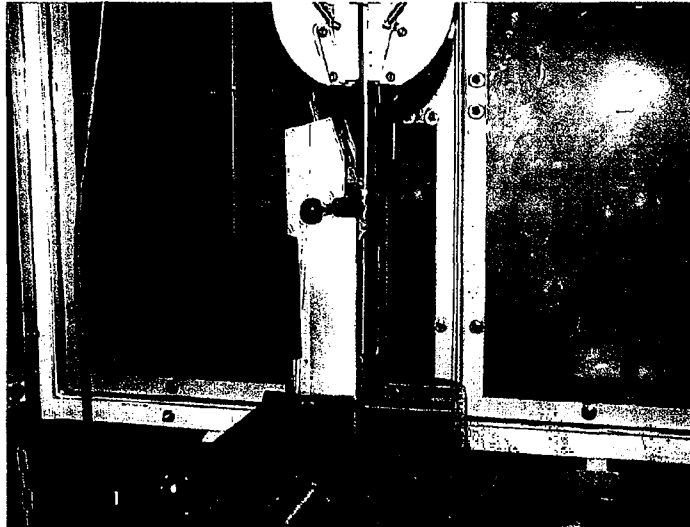
General setup for the Model 710 is shown in Fig. 1 and 2 below.

Fig. 1 - Model 710 Setup (Overall)

A standard Model 710 barreled action was assembled to an aluminum test stock which contained the as designed internal inletting cuts. The exterior of the stock was not contoured and was squared off. The stock was cut off in the back just behind the stock mounting nut. The front end of the stock and the barrel were also shortened to allow the entire assembly to be mounted in the Instron Model 8502 Tension/Compression Fatigue machine. The action was clamped vertically in a vise which in turn was secured to the Instron's table. The 1,000 lb. load cell was mounted in the Instron and a large diameter pin was secured in the upper jaws and aligned with the back of the firing pin head. The synthetic bolt shroud was removed from the bolt assembly to allow access to the firing pin head. The Instron machine was set-up for 0-.150 inch travel with a maximum load limit of 950 lbs.. All tested actions were checked for correct engagement before being mounted in the test setup. The action was operated to cock the firing pin and then closed. The safety was put in the ready to fire position and the load was applied at a rate of .1 inch/min. Force versus displacement data was captured for each action tested at a sampling rate of 10 pts/sec. Two 710 fire control assemblies were tested this way. In addition one 710 assembly was soaked overnight (24 hrs.) in Birchwood Casey solvent before testing. One 700 control sample was also tested.
