Magazine Box Shear
Strength Test

Remington Arms Company, Inc.

RE: TRIAL & PILOT MAGAZINE BOX TESTING**HISTORY:**

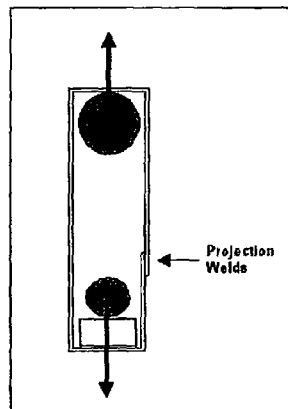
Figure 1. Schematic of the testing set-up for tensile testing the M/710 magazine boxes.

All 10 of the boxes tested passed the current specification criteria. The average failure load for all 10 tested magazine boxes was 3,037 lbf. The boxes were loaded in the Instron tensile testing machine as depicted in Figure 1. The first two magazine boxes tested did not fail the welds, but rather failed the magazine box material. The test set-up was then altered (for the remaining eight magazine boxes tested) by removing the small block in the bottom of the magazine box. This allowed for the failure of the weld rather than the material in six of the remaining eight magazine boxes tested. The average failure load of the last eight magazine boxes tested was 3,229 lbf.

A total sample of ten magazine boxes were tested to failure. As shown in Figure 1, the magazine boxes were loaded into the Instron tensile testing machine using two pins which passed through the ends of the magazine box and a small block which was meant to keep the front of the box square under the loading conditions.

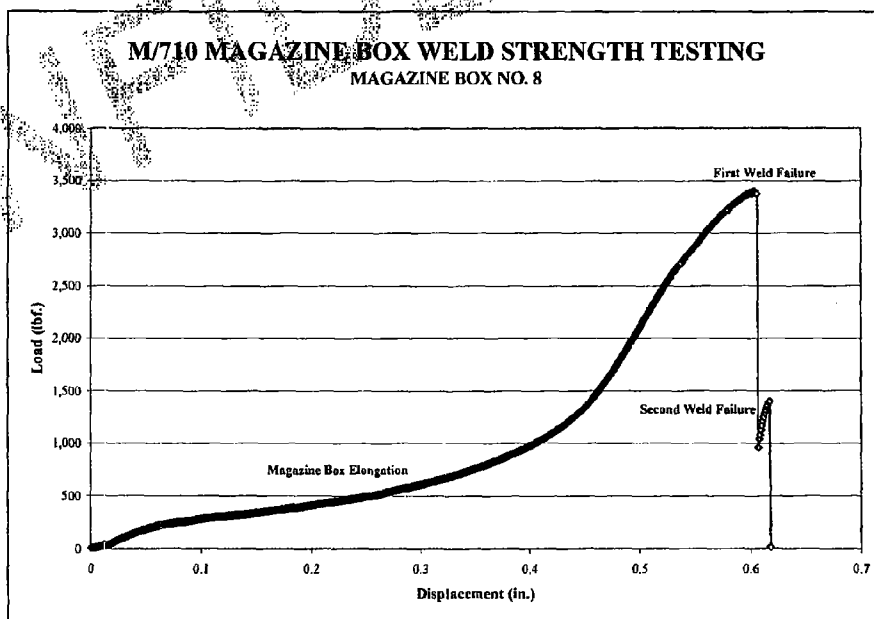
Figure 4. Load / displacement graph of test magazine box number 8.

Figure 4 presents an graph of a typical load / displacement curve for the weld strength testing. This graph has the key characteristics of the weld strength testing labeled directly in the regions of interest. These included the magazine box deformation (when the box deforms around the two fixture pins), the failure of the first of the two welds, and the failure of the second weld. This particular curve is of magazine box number 8.
