# **TRIAL AND PILOT TEST REPORT**

**Model 770 Stainless Steel  
Bolt Action Rifle**

**TLW 2305  
300 Win Mag  
30-06 Sprg  
243 Win Youth**

**TLW 2359  
7mm Rem Mag  
270 Win**

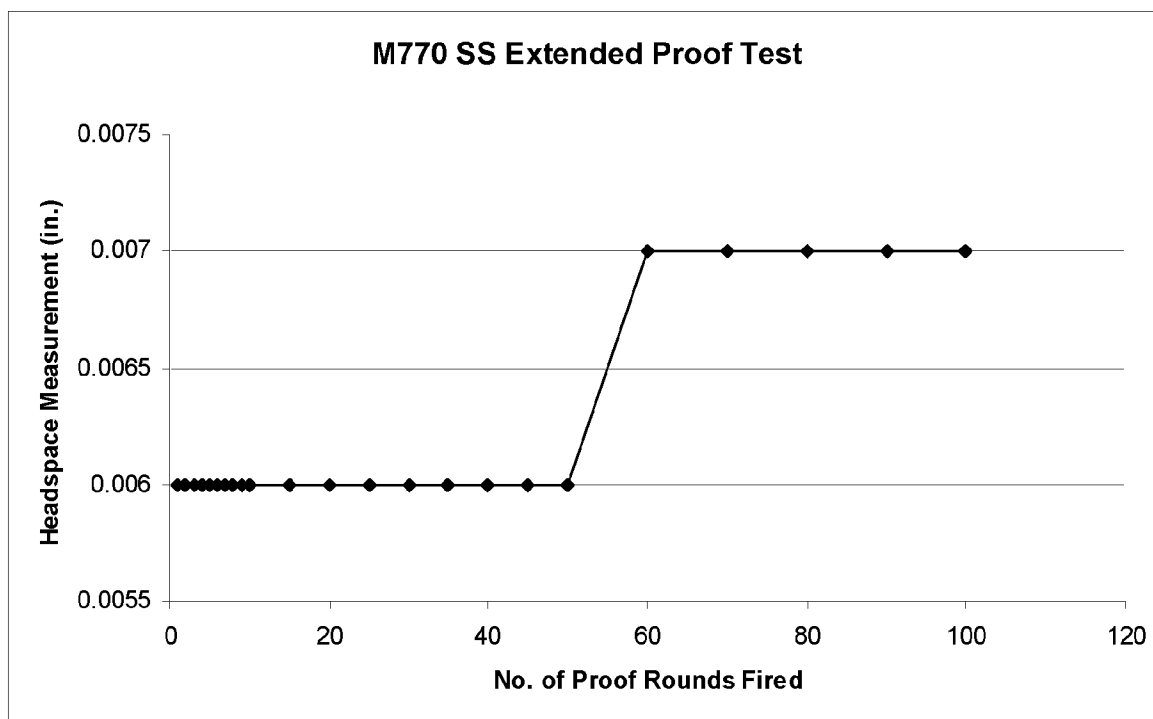
*Figure 1: Headspace growth during Extended Proof of gun A7.*

One rifle, A7, was selected to go through extended proof testing. Extended proof testing is an internal Remington abuse test designed to test the robustness of the firearms lockup. The test consists of firing 100 proof cartridges through the rifle and measuring headspace to monitor headspace growth. Figure 1 shows a graph of the measured headspace growth of gun A7 as a function of proof rounds fired. Total head space growth during extended proof testing was 0.001". This is considered acceptable head space growth for extended proof testing. Additionally, none of the fired proof cases showed any sign of damage.

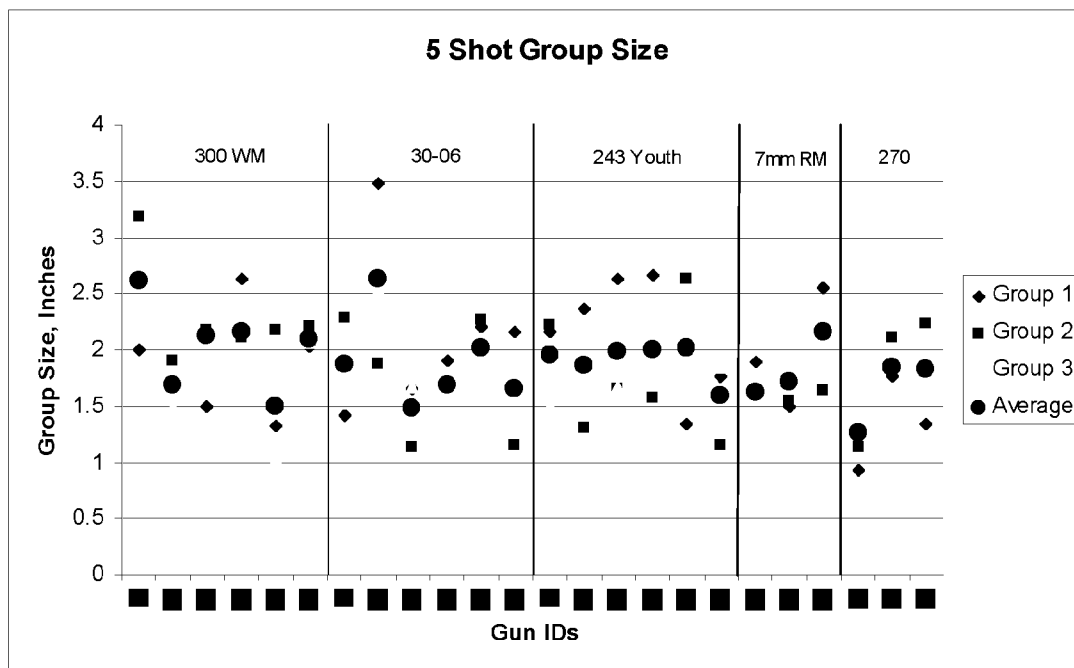
Figure 3: M770 SS 5 shot group accuracy graph.

The accuracy of the M770 SS was evaluated via firing a sample of rifles from each of the five calibers tested. The rifles were fired from the bench using the lead sled with the standard Bushnell 3 x 9 scope supplied with the rifle. Three 5 shot groups were fired for each rifle at 100 yards. The order of the shots was recorded for each group. This was done so that the first three shots could be measured as a three shot group. This allowed us to compare the data to Mayfield's historical data. For the A, B, and C series rifles the Oehler acoustic target was used to capture the shot order and group size. Paper targets were used to confirm the Oehler data. For the D and E series rifles the amount of shooting did not justify setting up the Oehler acoustic target. So the groups were shot directly on paper targets to be measured manually using the range camera to track the shot order. Graphs of the 3 shot and 5 shot group sizes are shown in figures 2 and 3, respectively. The overall accuracy summary is shown in table 2. This table also contains a summary of the accuracy data provided by Mayfield prior to delivery of these test guns for comparison. The overall average Elizabethtown 3-shot groups size was 1.47 inches. This compares to the Mayfield Historical 3-shot average group size of 1.31 inches. A statistical comparison can not be made between the Elizabethtown and Mayfield data, because the conditions under which the data was collected differed significantly. However, this testing did show that the accuracy of the M/770 SS was comparable to that as measured in Mayfield.

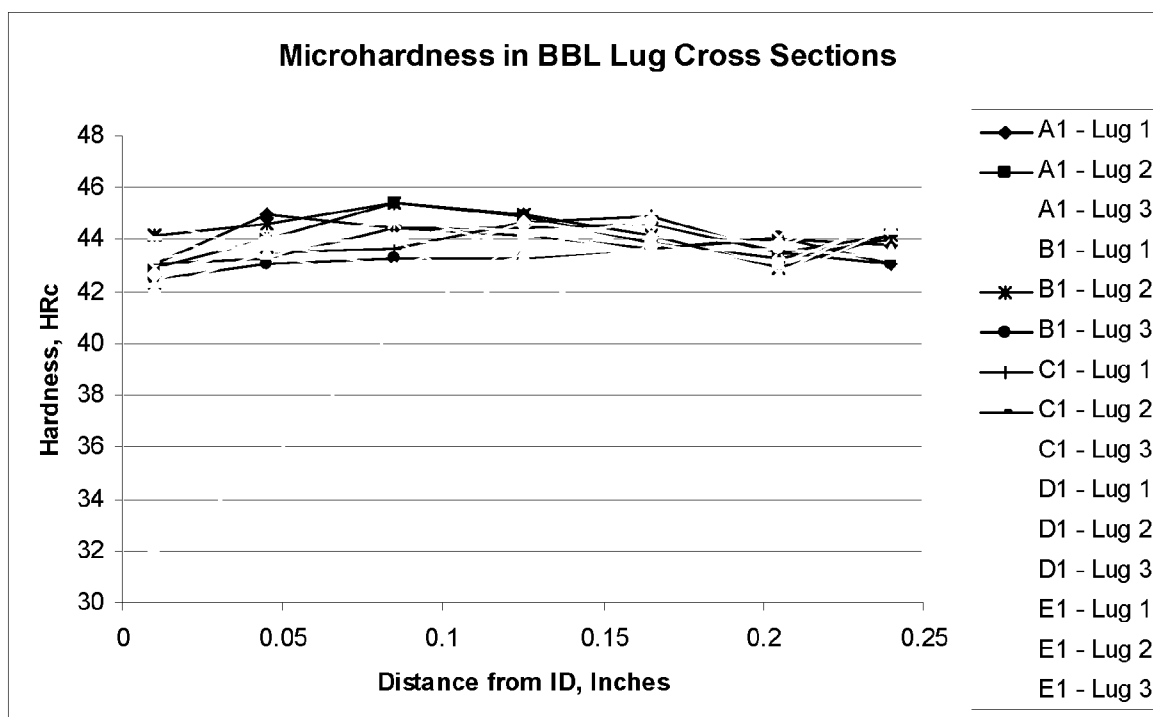
Figure 7: Locking Lug Microhardness Data.

Each barrel was sectioned in four locations. Three of these sections were through the bore and the fourth section was cut through the center of the locking lugs, as seen in figure 6. Microhardness measurements were taken on each of the three lugs in each section to compare to the OD hardness data. These measurements were from the ID to the OD. The microhardness was preformed using the 500g Vickers scale. This data was then converted to HRc and is show graphically in figure 7. The specification states that the OD hardness should be between HRc 37 – 45, which they were. The microhardness data collected showed that the lugs were through hardened. Two locations at the ID of lug 3 on the barrel from gun E1 did show lower hardness. This most likely indicates that the ID of this particular lug got warmer then the rest during the temper cycle.
