Test Report – Design Acceptance Test

M/710 Centerfire

Rifle

.30-06 Sprg.
(PART A)

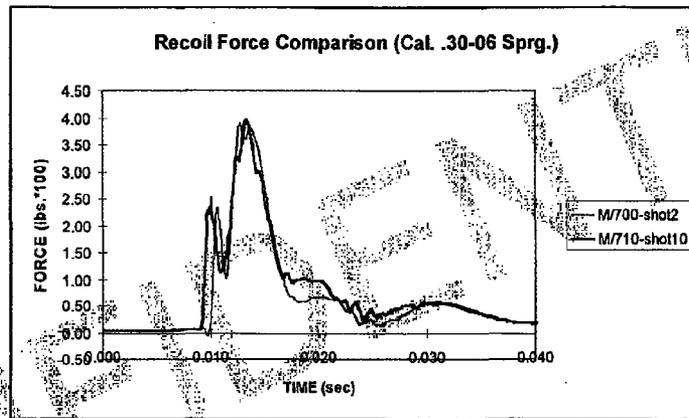
3.1.2.7 TLW0010J - Recoil Force

During Phase II a measurement of recoil force was made to compare the Model 710 with a Model 700 firing .30-06 ammunition. Statistical analysis of the data using ANOVA procedures indicates that there is a statistically significant difference (at the 95% confidence interval) for both the peak force measurement and the area under the force-time curve. While the data indicates a statistical difference, from a practical point of view the differences are insignificant. The difference of approximately 8-9 lb. in peak values is unlikely to be discerned by most shooters as being a difference in recoil. Studies done in 1948 (see Remington Progress Report AB-48-31, prepared by F.G. DuPont) indicated that "... a minimum difference of 20 lbs. in maximum shoulder force (i.e. peak force) between guns is indicated as being required for reliable discrimination by the shooter." (Page 2 of ref. cited above.) In addition, the above reference states "Subjective recoil sensation is found to correlate well with maximum shoulder force." (Page 2.) (See TLW0010J; B.?)

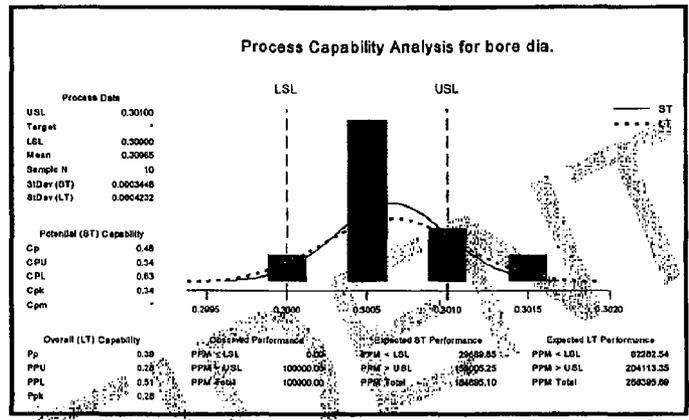
Bore diameter was measured and found to average .3007" against a specification of .300"/.301". (See Section TLW0010W; E.2)

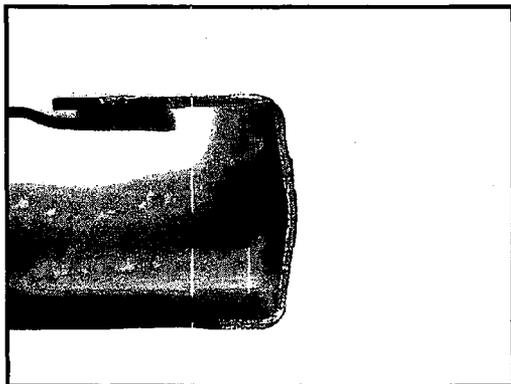
Magazine Box showing deformation at front of box. Note also the separated sides of the box where the welds failed.

The major problem experienced during this test was related to the magazine box. Two problems, possibly related, were noted. First, the boxes failed at the assembly welds (see picture below) and second, the boxes were continually deformed by being bowed out at the front of the box by rounds impacting the box. This required that the boxes be pounded back into shape to continue the function testing. There were also dents in the front of the magazine boxes from the bullet points. (See picture below.)

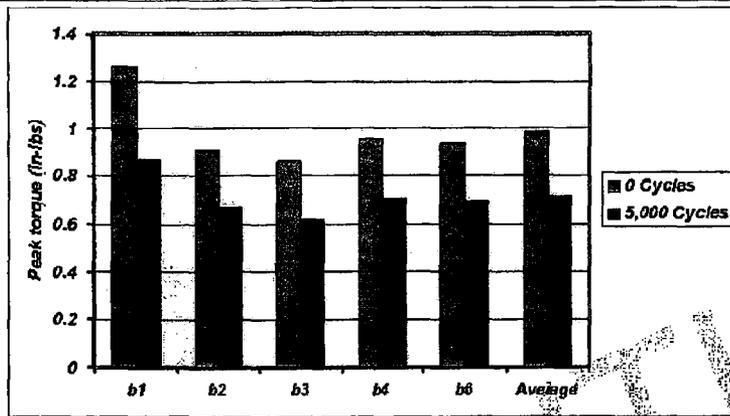
Figure 3. Peak locking torque, before and after 5,000 cycles, average of two measurements.

The following two charts were taken from the report authored by B.Rages - "Model 710 ISS Dry Cycle" dated 10/24/00. This report can be found in its entirety in part B.2 (See Section TLW0010AE; B.2)

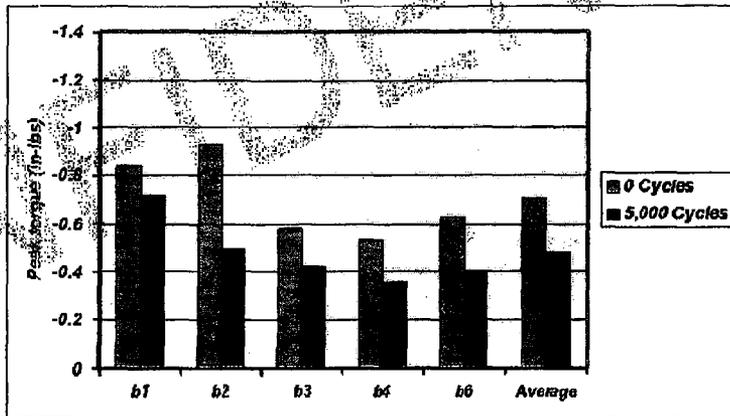
Figure 4. Unlocking torque, before and after 5,000 cycles, average of two measurements.

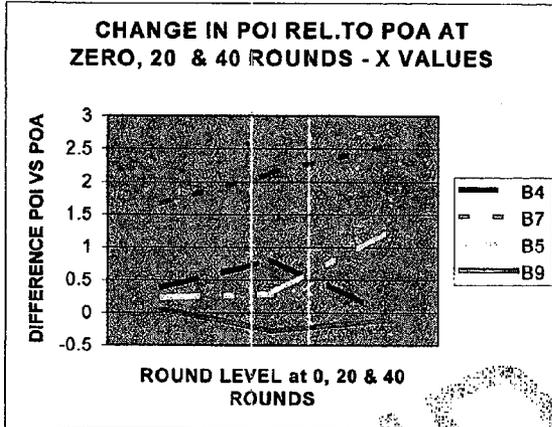
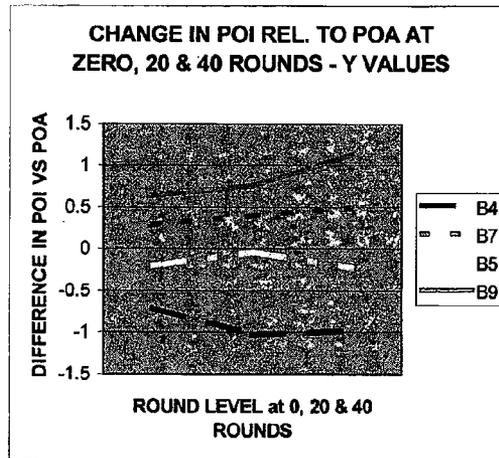
3.3.1.1 TLW0010AF - Point of Impact

This test was conducted to determine if the Scope system supplied with the M/710 would remain "stable" and maintain scope settings after live firing. Two charts are shown below show the change in Point of Impact (POI) vs. Point of Aim (POA) for four Model 710 rifles over a forty round test

Note that Rifles B-4 and B-7 were shot using two Bushnell scopes and Rifles B-5 and B-9 were shot using two Tasco scopes. Ammunition used was Remington R30064, 180 gr. Range was 100 yards.

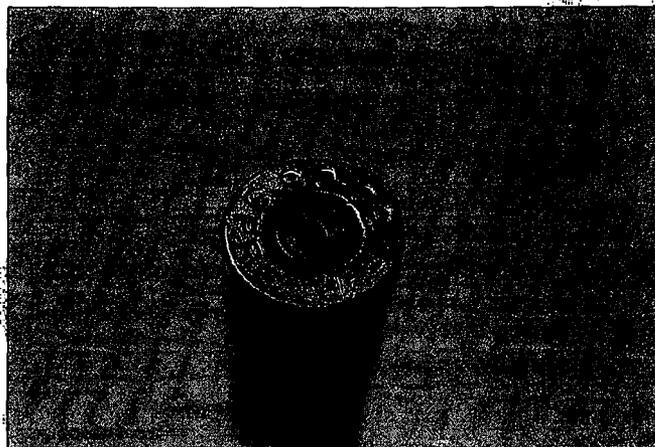
**Pierced Primer Test****3.5.2.2 TLW0010AX – High Pressure Test**

For this test, a firing pin was altered to make a “wedge-shaped” point. This type of firing pin point usually produces a pierced primer when fired. The purpose of piercing the primer is to allow high-pressure gases to escape into the action and thereby determine the effect of high-pressure gases when dumped into the bolt, magazine box and receiver areas. A standard round of .30-06 ammunition was used for this test. To determine if escaping gas pressure ejects particles that might hit a shooter witness paper is placed just behind the rifle. There were no indications of particles being blown back toward the shooter when this test was conducted.

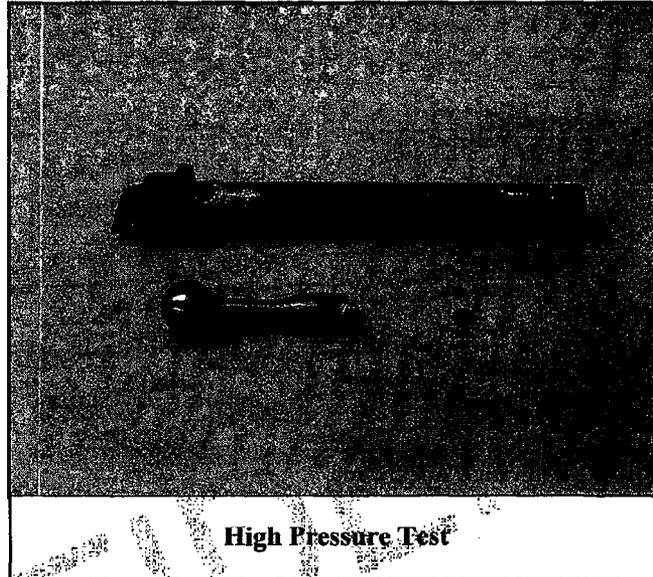
This test evaluated the effects of extremely high pressure on the strength of the rifle system. A purpose of this test is to determine the extent of damage that might occur if an individual purposely or accidentally produces a handload that generates a load approximately twice normal factory load pressure. The approximate pressure generated in this test is in the range of 120,000 psi. Although the bolt handle broke off the bolt, the bolt lugs held as did the locking lug area of the receiver. It is believed that the bolt handle was broken during the test when the lanyards used

to close the bolt remotely placed excessive stress on the bolt handle during recoil. This stress combined with a poor braze attaching the handle to the bolt resulted in the failure.

There were no other indications of damage to the firearm. No damage to the witness paper was observed.
