Cust Comp Harlow

34129

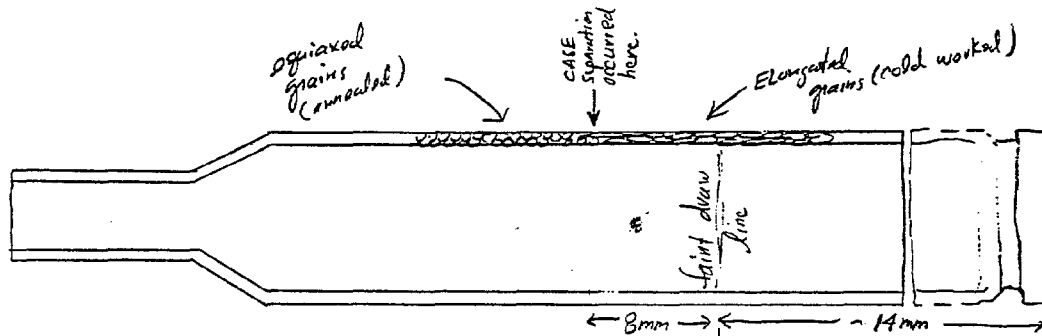
The fired unseparated case was cross sectioned and polished to reveal the grain structure (Fig 1).

Fig 1. Cross section of the cartridge

A faint draw line was observed on the inside of the case as indicated in Fig 1 ( $\approx 14\text{mm}$  up from the base). The draw line did not produce any reduction in side wall thickness. About 8mm up from the draw line (towards the mouth) the grain structure changed from elongated cold drawn grains to an annealed equiaxed grain structure. The case separation on the returned cartridge occurred exactly where the grain structure converts from elongated to equiaxed. I don't feel the shell was defective, only it failed in the most probable spot after several reloadings.
