TRIAL AND PILOT TEST REPORT

Model 770 Stainless Steel Bolt Action Rifle

**TLW 2305
300 Win Mag
30-06 Sprg
243 Win Youth**

**TLW 2359
7mm Rem Mag
270 Win**

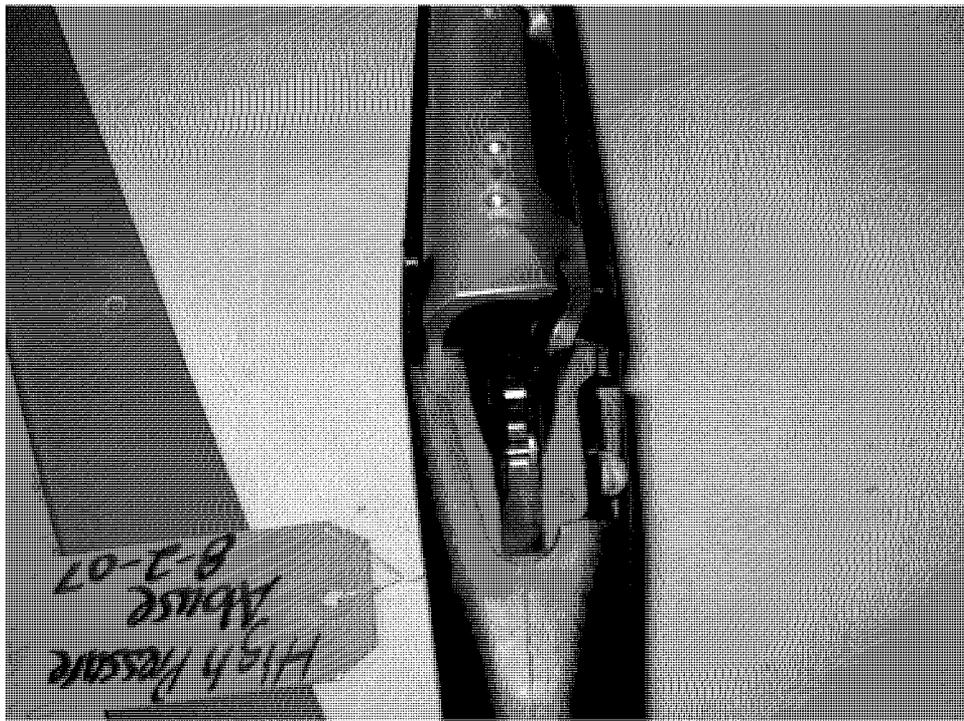
Figure 12: Gun A9 post abusive testing.

High pressure abusive testing was performed on one rifle, A9, using SAAMI and Remington test procedures. The rifle selected for this test, A9, was chambered for the 300 Win Mag cartridge, representing the most severe scenario. The rifle had a strain gage place over the chamber portion of the barrel in the hoop direction. Three SAAMI reference rounds were fired through the rifle followed by three SAAMI Proof rounds. The rifle was then subjected to a 120,000 psi abuse round. The load for the abuse round was 71.5 grains of IMR 3031 Lot # E97AU19L1500. The result of this test were consistent with previously tested carbon steel product. The rifle remained intact; however, the strain data captured, seen in figure 11, shows that the barrel did take a permanent deformation set of approximately $300 \mu\epsilon / \text{in}$. The bolt required the use of a hammer to be opened. Figures 12 – 14 documents the condition of the rifle post test.

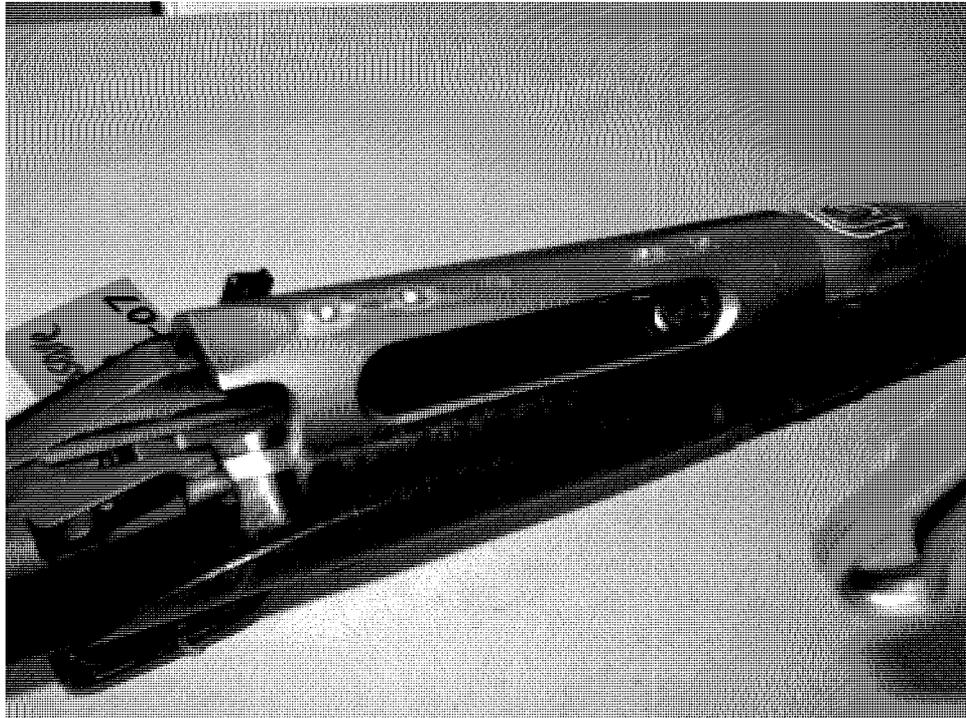
Figure 13: Gun A9 post abusive testing.
