Benjamin Naiman, Capt.
25 Pinsker Str.
Petah-Tiqva, Israel.

Petah-Tiqva, March 30-th, 1956.

Remington Arms Company, Inc.
Ilion, N.Y., U.S.A.

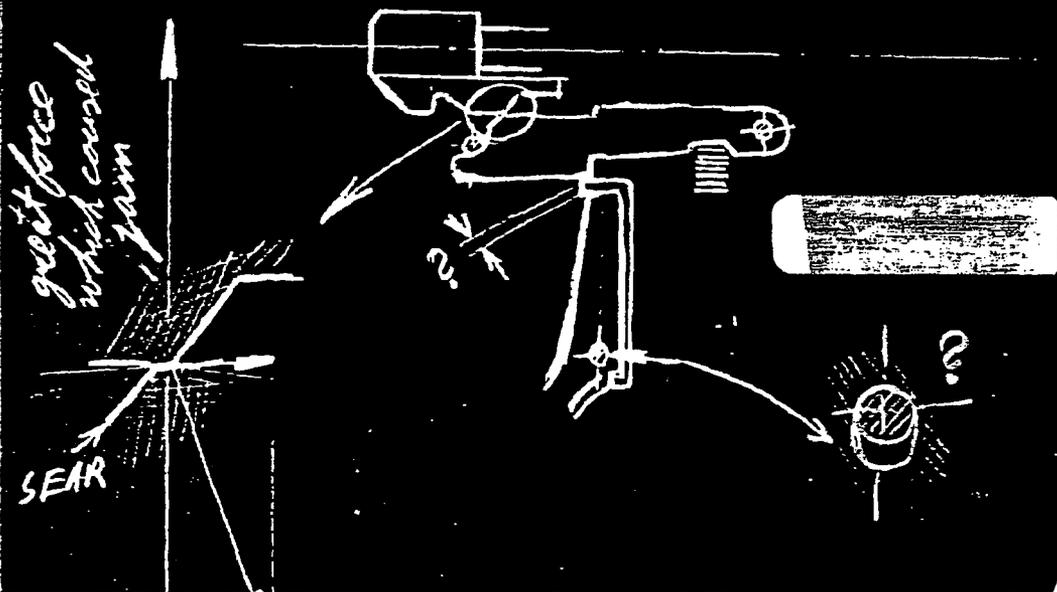
FIG 4

PIN EXTENTION

I had to order a new connector with a thicker head and, seeing no reason why it should not be connected to the trigger, I fixed the two bodies together by means of a 1/8" screw. The latter arrangement enabled me to replace the original heavy trigger spring by a lighter one aiming for a lighter pull. Please inform me whether you approve of the above. The click adjustment of the trigger is most convenient but unscrewing the trigger adjusting screw too much, causes the "trigger adjusting ball" to be pushed outside by the spring and removing of the stock becomes necessary. I suggest that the above be eliminated by addition of a thin pin-extension to the "trigger adjusting screw" (see fig. No.4). It proved successful on my rifle.
