**REMINGTON ARMS COMPANY INC.  
ILION, NY PLANT SITE**

**TEST REPORT**

**M/700 XMP Trigger Assembly  
Updated MIM Sear Verification**

**Request # 20080006**

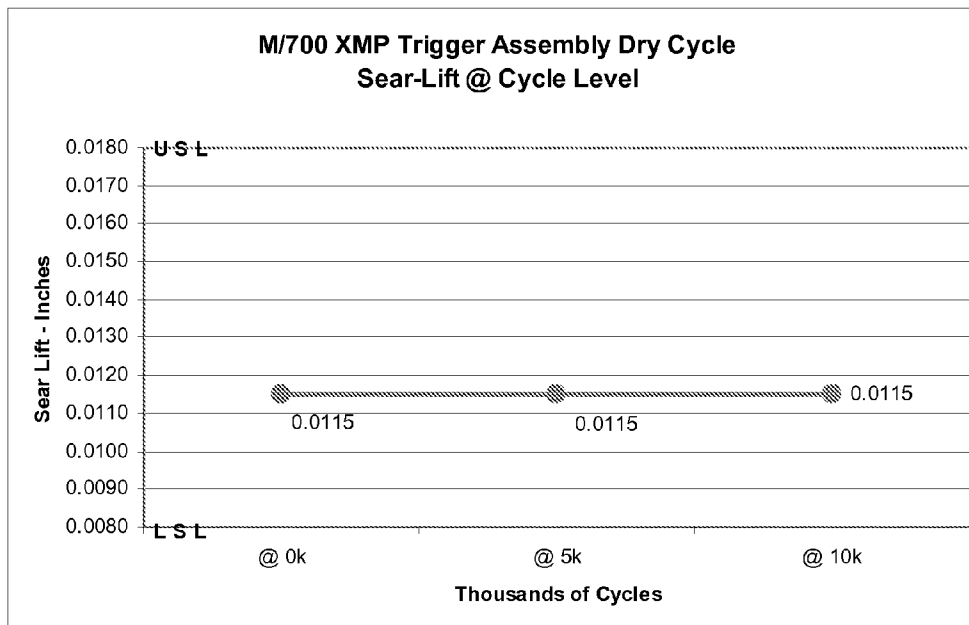
**Dry Cycle** - The dry cycle phase was completed without any problems - no breakages or abnormal wear was evident. The measurements were consistent with previous testing done on the trigger assemblies.

The testing began with 10 trigger assemblies being set for trigger pull, and the sear lift and safety on/ off forces measured. They were then dry cycled for 5,000 cycles with trigger pull and sear lift measured. They were then completed to 10,000 cycles and measured for safety, trigger pull, and sear lift.
