E. I. du Pont de Nemours & Company
(Incorporated)

SUBJECT USE OF DU PONT OVAL TRADE-MARK BY
REMINGTON ARMS COMPANY, INC.

A Manual
for the Standard Use
of the Company Name,
Trademark, and Slogan

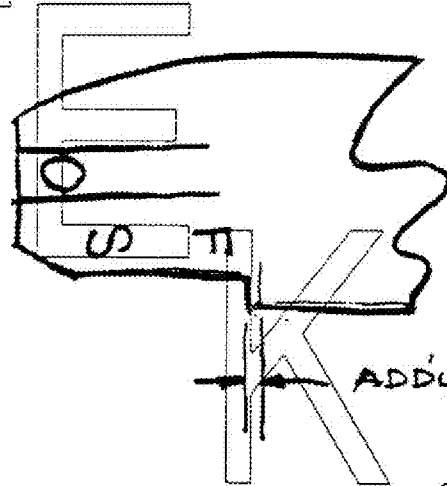
1. IF MOTION FORWARD OF "F" DETENT POSITION IS REQUIRED, THEN INVESTIGATE ADDITIONAL RECEIVER CLEARANCE. ASSEMBLERS ARE OFTEN NOW FILING RECEIVER TO PROVIDE THIS.

2. IF MOTION REARWARD OF "S" DETENT POSITION IS REQUIRED, THEN INVESTIGATE PRESENT INTERFERENCE(S). THIS IS NOW DIFFICULT TO ATTAIN.

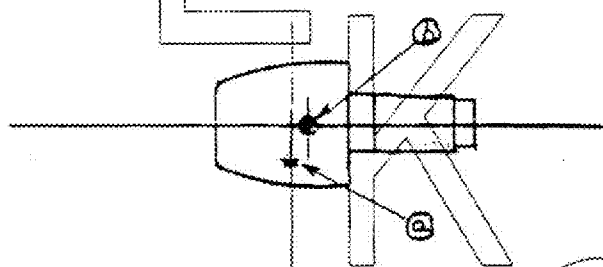
STA. 2 - (A) BUTT DRILL BOLT LATCH PIVOT HOLE & (B) ROUGH DRILL LATCH SLOT (CENTER)

8-STATION DIAL TYPE TRANSFER MACHINE. (LOAD AT STA. 1)

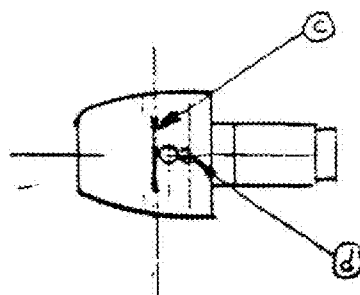
STA. 3 - (C) DRILL B.L.P.H. & (D) ROUGH DRILL LATCH SLOT (FRONT)

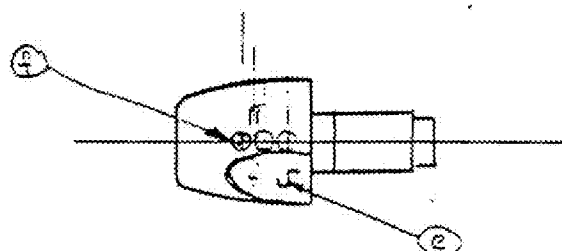
STA 4 - (E) MILL RIGHT SIDE (m/60C D.A.R.) & (F) ROUGH DRILL LATCH SLOT (REAR)

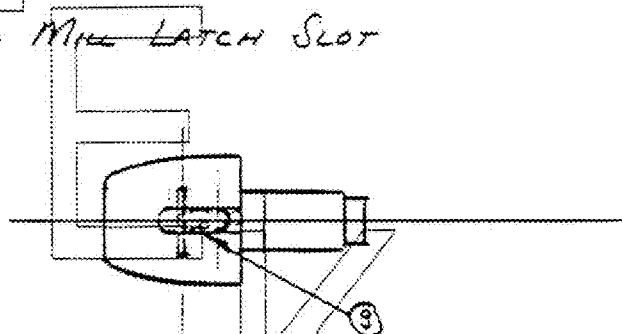
STA. 5 - ⑨ MILE LATCH SLOT

OPERATION 24 - DESCRIPTION CONT'D.

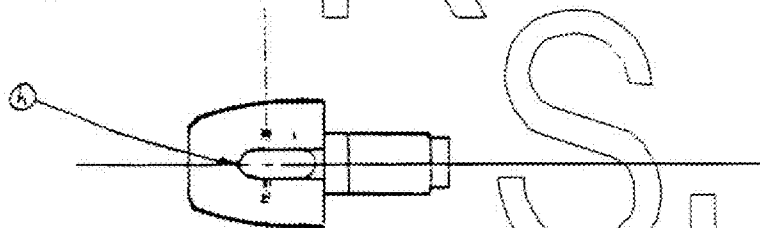
STA. 6 - ⑥ BUTT DRILL SPRING PLUNGER HOLE

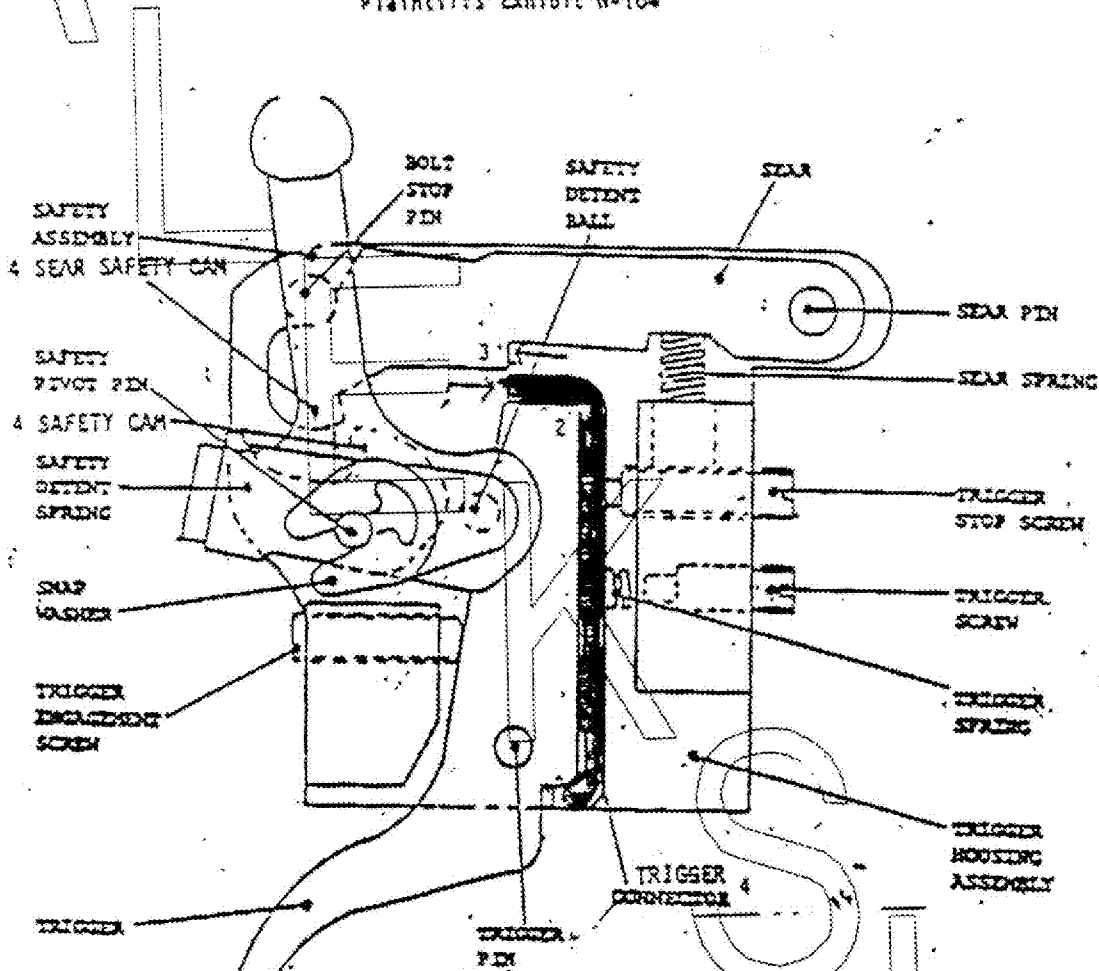
Appellees Addendum 6
Plaintiffs Exhibit G-104

1. The safety cam rotates counterclockwise contacting the sear safety cam and lifting the sear from the trigger connector when the safety lever is moved forward to the on safe position. The sear lift in the Lewy rifle was .007 inches (T. 7/35).
2. This drawing does not show the vertical clearance between the trigger and trigger connector which was .010 inches in the Lewy rifle (T. 7/38).
3. The horizontal interference between the trigger connector and sear which was up to .003 (.010 -.007) inches in the Lewy rifle prevents the trigger connector from returning under the sear to provide support when the safety is moved to the off position (T. 8/52).
4. Appellees have added labels to G-104 in order to pictorially explain the function of the Walker fire control system and F3Rs to the Court.

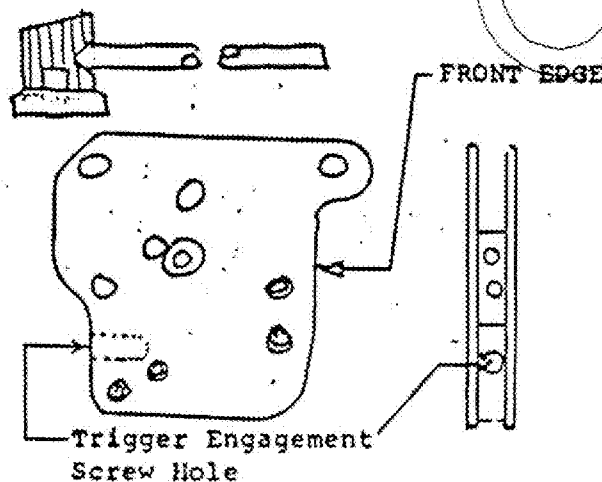
(figure 1)

1. Clean and prime Trigger Engagement Screw hole. (see figure 1)
 - a. Position Housing on its front edge.
 - b. Air clean Trigger Engagement Screw hole and Housing.
 - c. Spray Trigger Engagement Screw hole with "Locquic Primer T" (Aerosol can).—Housing must air dry (no hose) at least five minutes after spraying before they are used.
 - d. To Trigger Sub-Assembly -

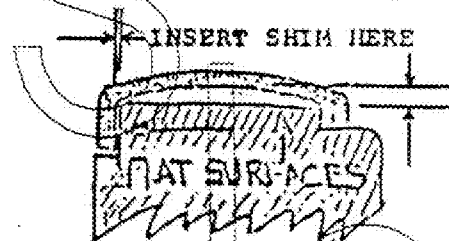
Fig. 2. GOOD

- a. Inspect long inside connector surface and inside surface of long (top) leg for flatness. Hold connector against flatness block with light finger pressure.
- . If no light shows between back and long leg of connector and block surface, then connector is passed (see Figure 2).
 - . If light gap shows, measure gap with .004 shim. If gap accepts shim without moving connector, then reject connector (see Figure 3).
 - . Reject connector if it rocks on flatness block at all (see Figure 4).
 - . Front edge of long (top) leg must be square with shoulder on flatness block (see Figure 5).

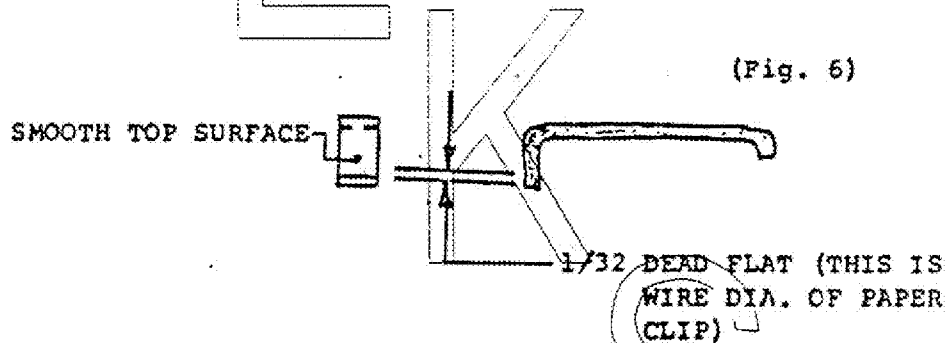
- b. Check connector for maximum width over full length.
Reject parts over 0.172. Use receiving gauge C-44522.
- c. Smooth top surface of long leg of connector. Use crocus cloth. Surface must be: (see Figure 6)
 - . Smooth
 - . Burr-free
 - . Dead flat with 1/32" of end

Check for smoothness and burrs with tip of finger.

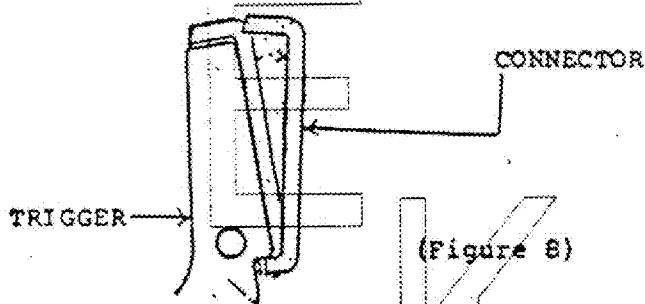
- a. Fit passed connector to passed trigger and check for minimum working clearance (slipfit).
- . Connector must rotate freely around bottom (short) leg without binding on top of trigger (see Figure 8).

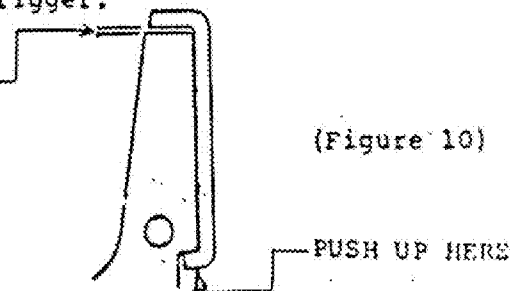
Insert shim from
this direction.

- . File bottom notch on trigger only if required to remove bind. Filed surface must be flat and square with sides of trigger. Use filing fixture D-44521.
- b. With same trigger and connector, check for maximum working clearance (see Figure 10).
- . Push connector tight to trigger at bottom.
- . Insert shim stock in clearance from front to back. .006 shim must not go. If shim goes without moving connector, scrap trigger.

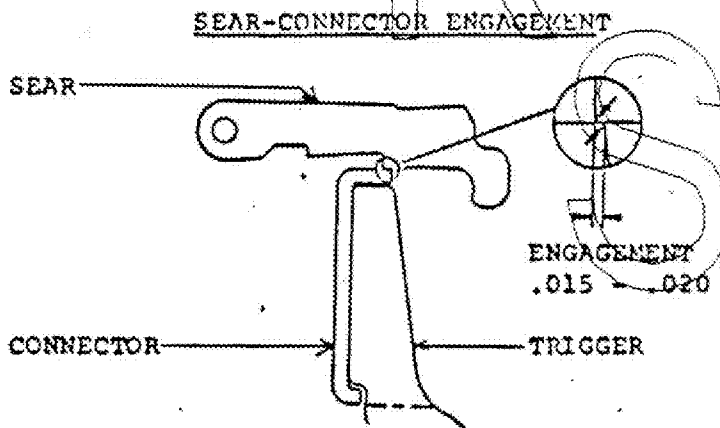
(Figure 12)

- c. Adjust Sear-Connector engagement (.015 - .020) to correct comparator screen line by turning Trigger Engagement Screw slowly clockwise (to reduce engagement) (see Figure 12).

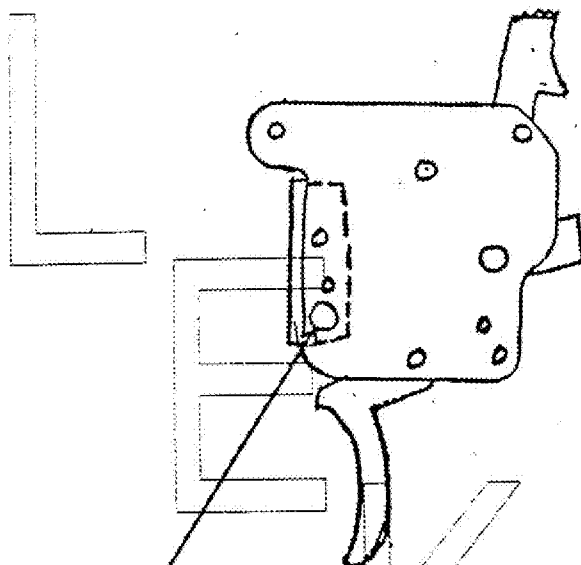
(Figure 14)

- Stamp lower left front corner, as shown in Figure 14, with correct assembler identification. Use 1/16" size character.

STAMP HERE. MARK MUST BE ON HOUSING WHERE
FULLY SUPPORTED BY SPACER BLOCK.

10. Mark correctly assembled and checked Trigger Assembly with Assembler's identification. (See Figure 14)
- Locate Trigger Assembly in stamping fixture.

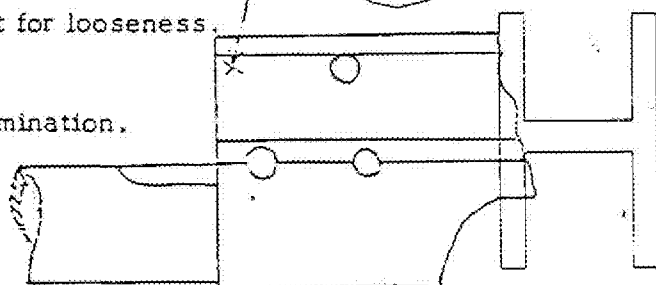
1. Measure and record width of receiver at area adjacent to take down screw hole. Micrometers. See sketch.
2. Check barrel and receiver joint for looseness.
3. Pivoting the gun on the toe of the stock, raise the muzzle one foot above a solid wood block. Allow the gun to fall freely so that the muzzle strikes the wood block. Perform a total of five times.
4. Measure and record width of receiver.
5. Check barrel and receiver joint for looseness.
6. Pivoting the gun on the heel of the stock, raise the front end of the receiver one foot above a solid wood block. Allow the gun to fall freely so that the receiver strikes the wood block. Perform a total of five times.
7. Measure and record width of receiver.
8. Check barrel and receiver joint for looseness.

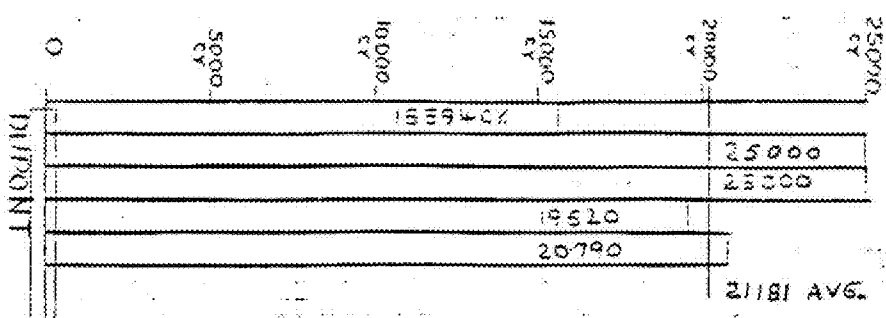
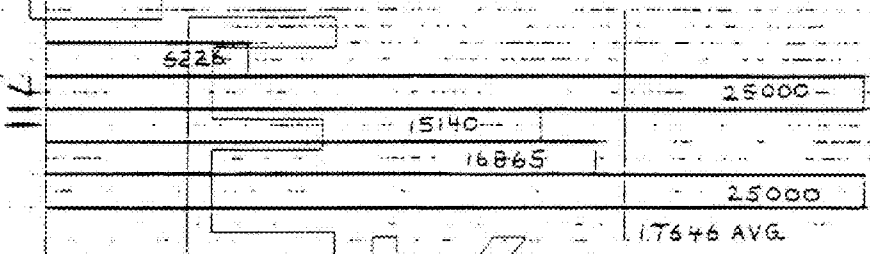
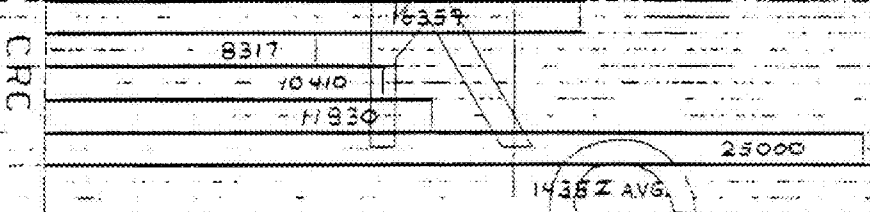
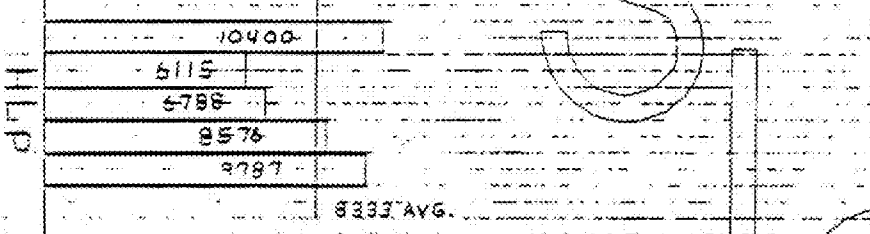
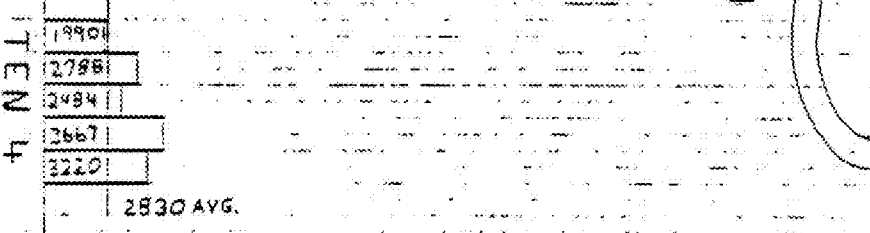
SPRAY LUBRICATION EVALUATION M700 COCK & FIRE SIMULATION

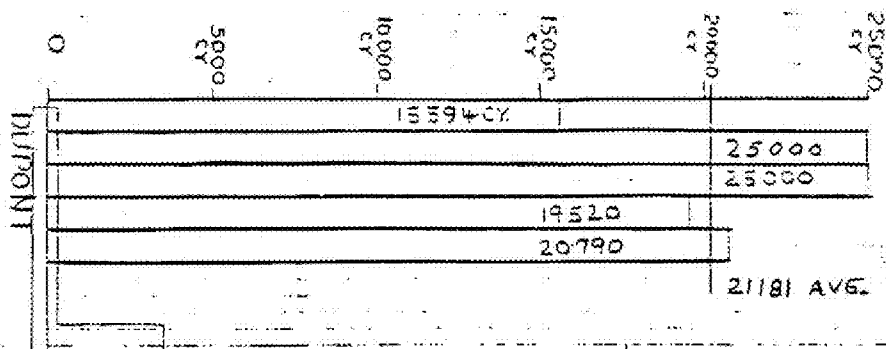
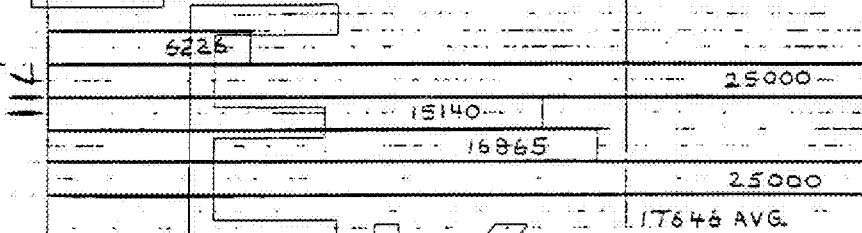
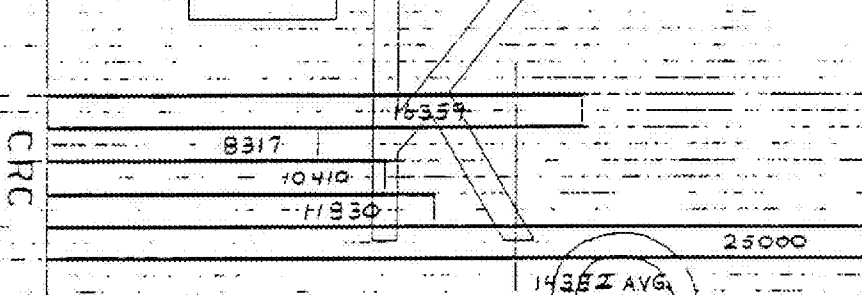
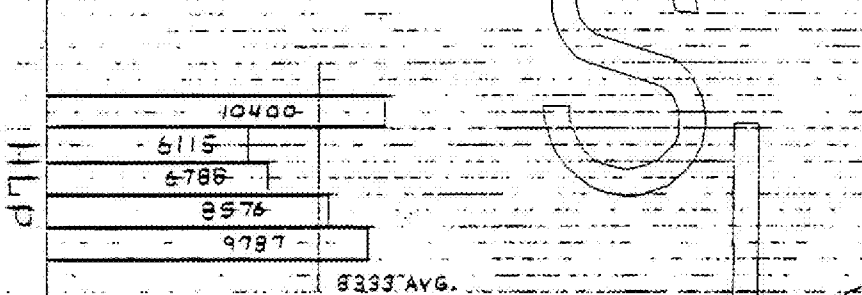
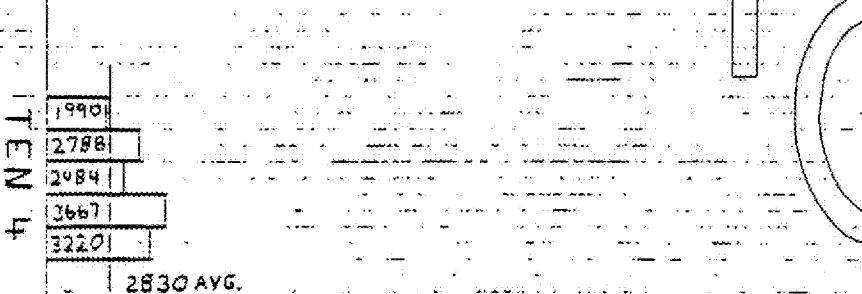
APPENDIX B
(Graphic Presentation)

SPRAY Lubrication EVALUATION: M700 COCK & RIDE SIMULATION

A graphical analysis comparing the lubricants tested to their cycle life, and their cycle life to the simulator used is found in Appendix "B".

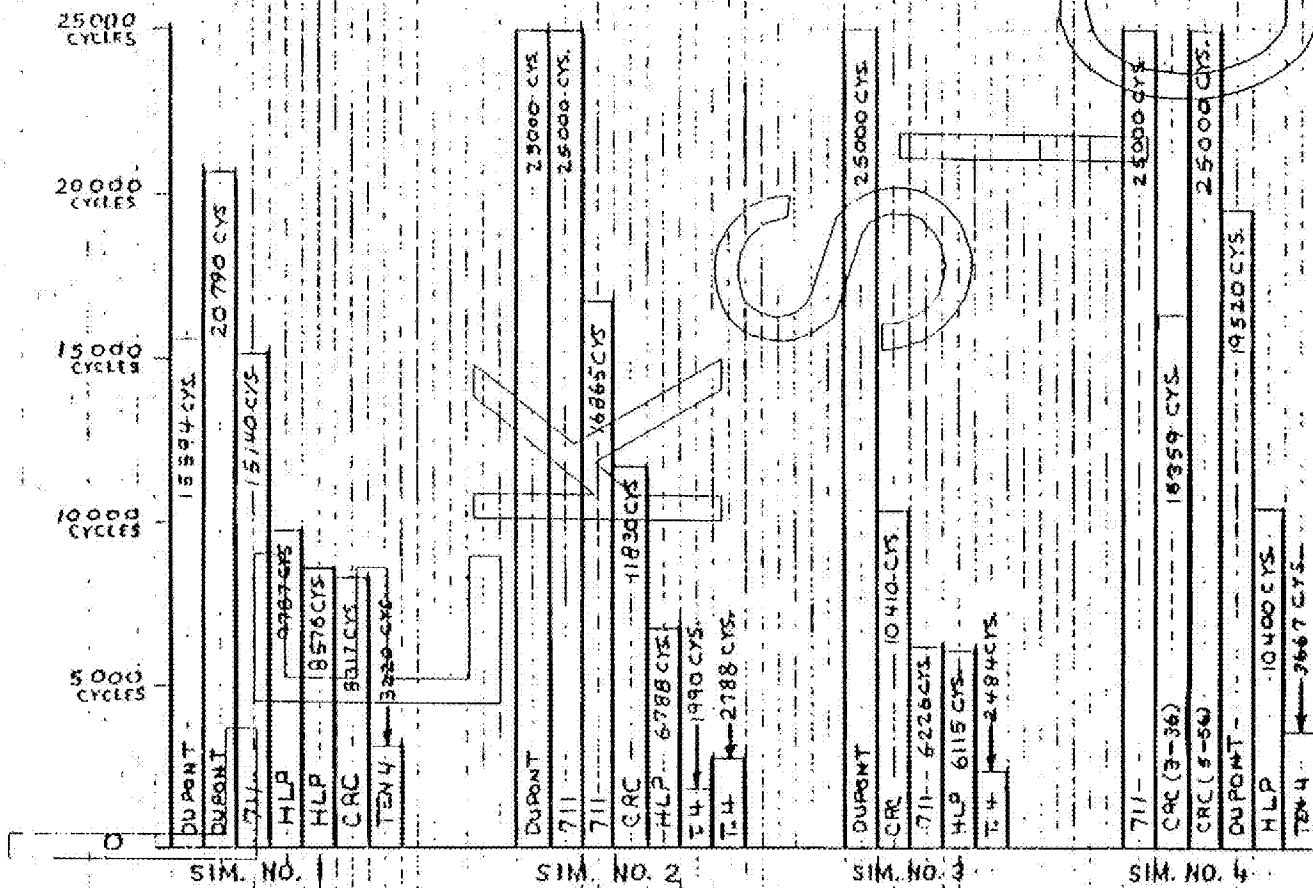
SPRAY LUBRICATION EVALUATION - M700 COCK FIRE SIMULATION

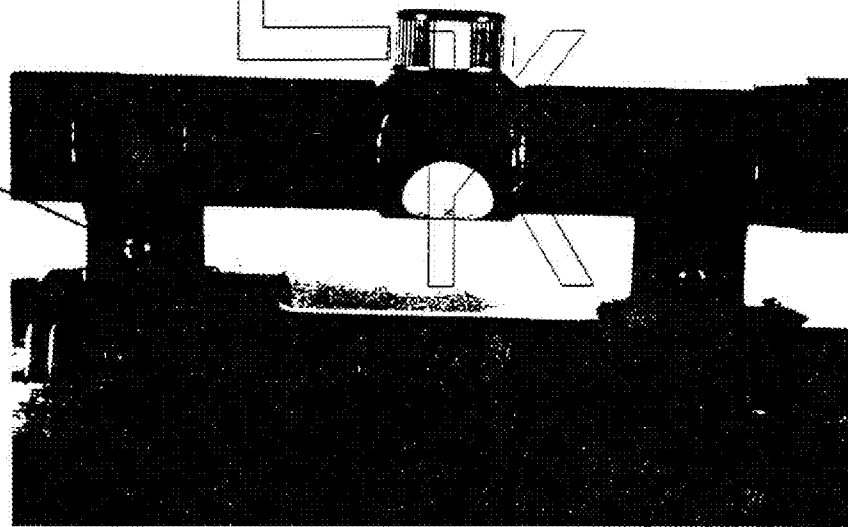
Simple #2 is in keeping with the request to be made - cheap ⁴²⁸ I mean "cost efficient." It has been designed as a stamping, to be attached to a dovetail as in Sample #1, it uses one screw to clamp and also hold the scope.

This sample, as sample #1 is of two different heights and would be stopped by the second bracket.

Parts are 1020 or 1095 Mat'l. spring tempered, to ensure a good grip. Large diameter that wraps around scope tube is slightly smaller than tube to ensure interference and a good grip.

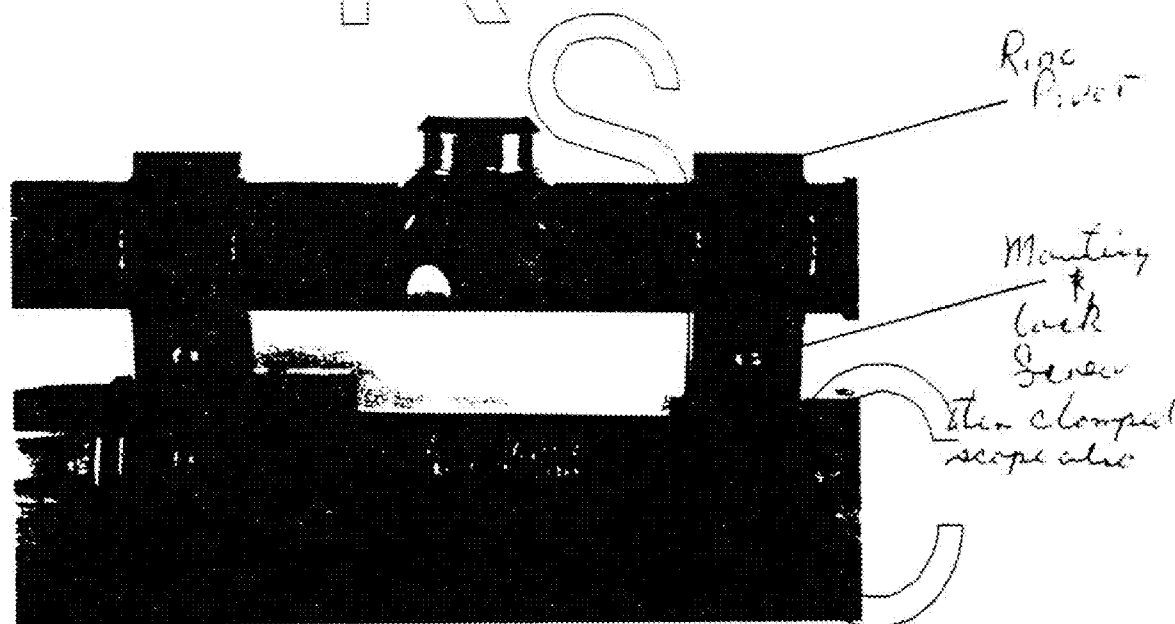
Sample #3 is a variation of #2 hopefully
 a little easier to mount and assemble.
 This Mount was also designed as a stamping
 to be heat treated and mounted on a dove-
 tail cut in the receiver.

Picture to explain - One screw Mounting
 and clamping

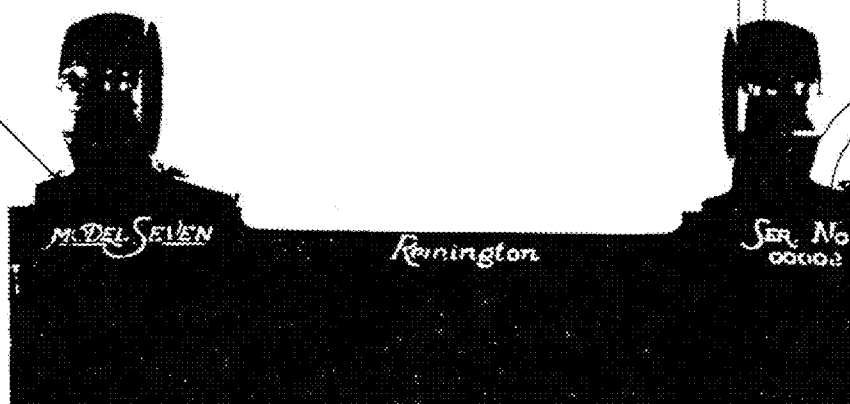
It does not use a mounting block instead it ~~is~~ ^{is} directly to the receiver in mounting like the ~~sample~~ ^{sample} complete disassembly is made when removing the mounts.

Mounting
Scopes
each
ring

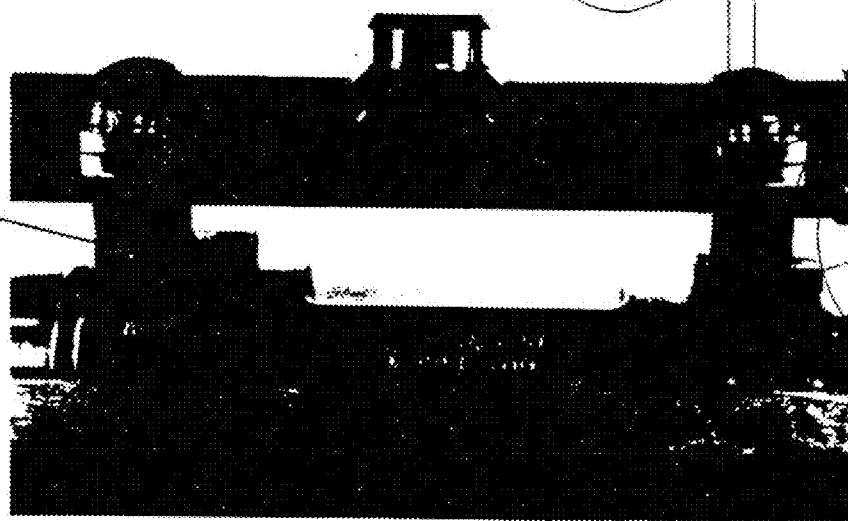
The mount is similar to those marketed by
 Weaver and Tasci it uses a separate block
 to mount the ring and scope to the rifle.
 The sample shown does not have to be completely
 disassembled to remove from the rifle. It is
 shown as having two ring heights but
 could also be made for one ring height
 and two different block heights.
 Blocks are screw directly to receiver.

Lock
Screw
(3)

Mounting
Block -
RearLock
Screw
(3)EXPERIMENTER
WITNESSFred C. Martin
Chas. E. EddyDATE
DATEMounting Block - Front
8-21-81
8/16/82

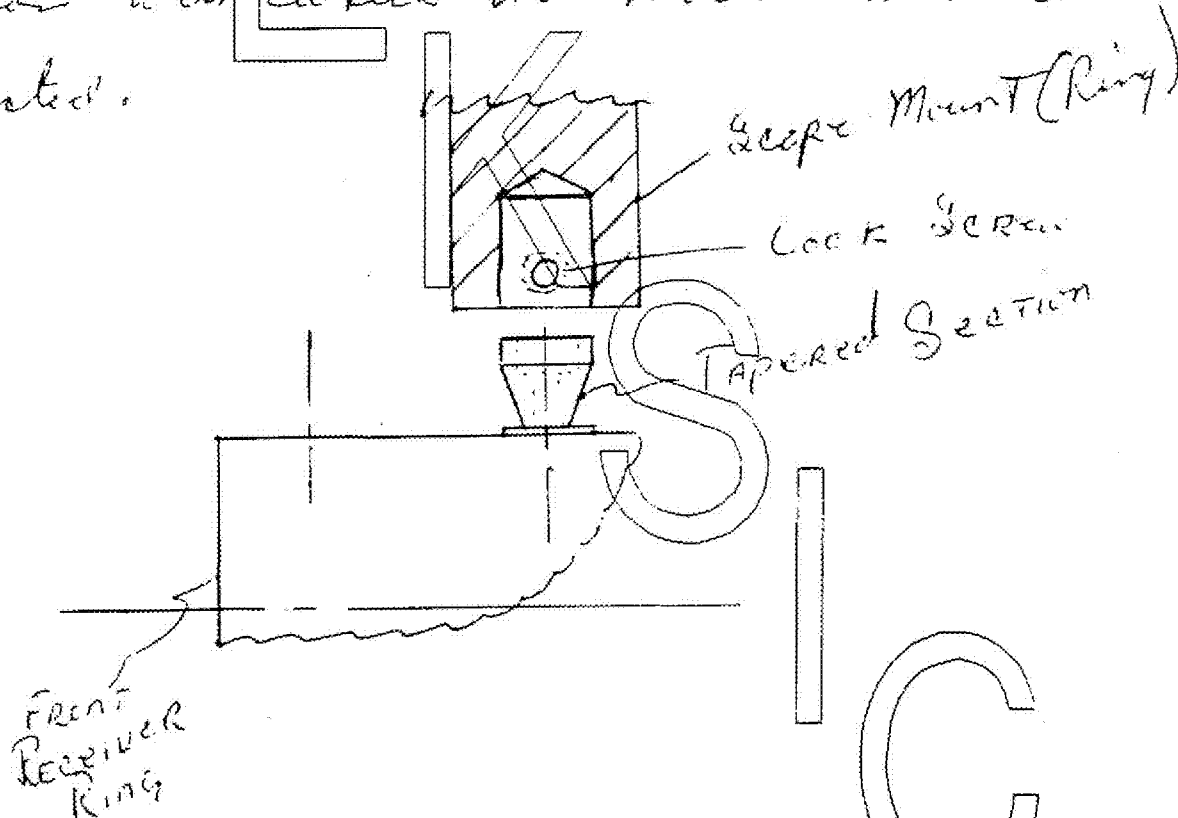
A scope mount system that uses a mounting bushing instead of a mounting block was developed for use on the M-700 Bolt Action Rifle.

The bushing was formed with a tapered section with which the mount lock screw contacted.

Bushings was countersunk for mounting screw and could be mounted in any of the four scope screw holes on the receiver to facilitate the use of a variety of scopes.

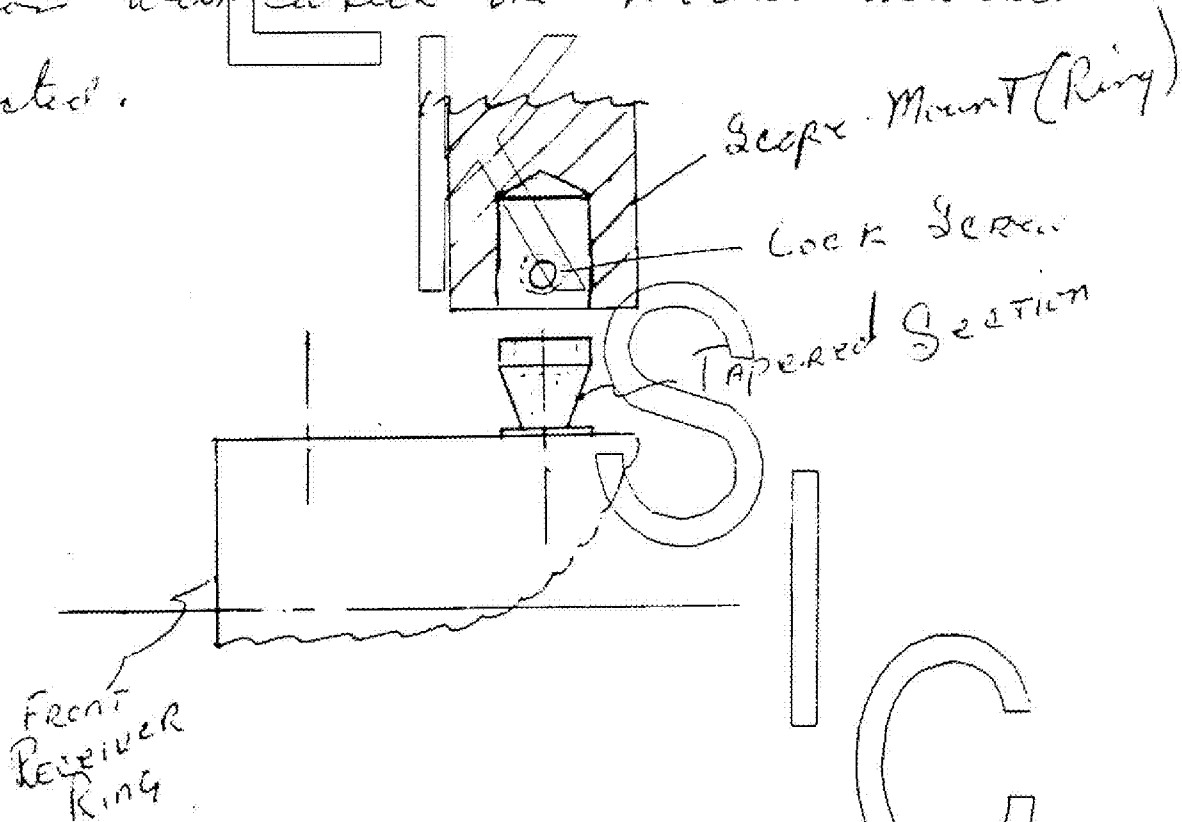
A scope mount system that uses a mounting bushing instead of a mounting block was developed for use on the M-700 Bolt Action Rifle.

The bushing was formed with a tapered section with which the mount lock screw contacted.

Bushing was countersunk for mounting screw and could be mounted in any of the four scope screw holes on the receiver to facilitate the use of a variety of scopes.

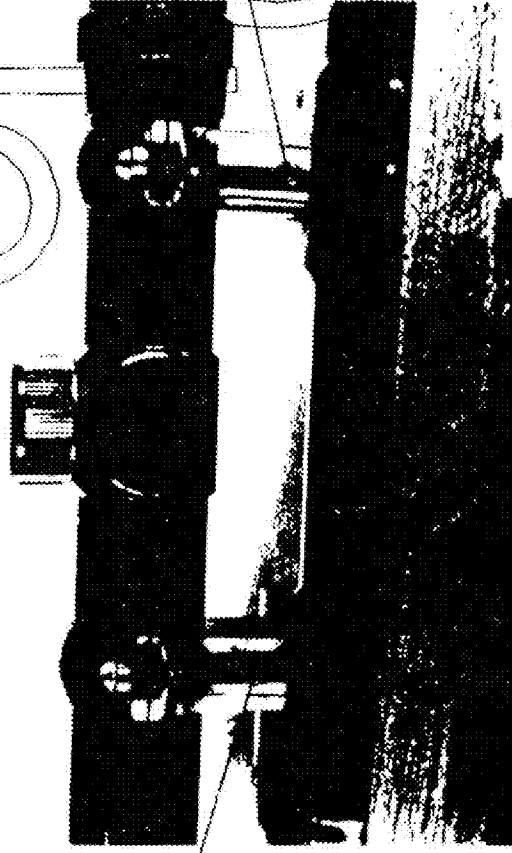
Bottom of the Scope Ring had been drilled and removed from a ship felt over the bushings. If the individual sawing the rifle wished he could increase the scope by loosening the lock screws and still be able to use the same sight without interference. Photos are the Scope mounted. Locked in to position. It's shown bushings can be moved for different scopes.

Lock
Screw

Lock
ScrewLock
Screw
1 inch dia.
1/2 inch diam.

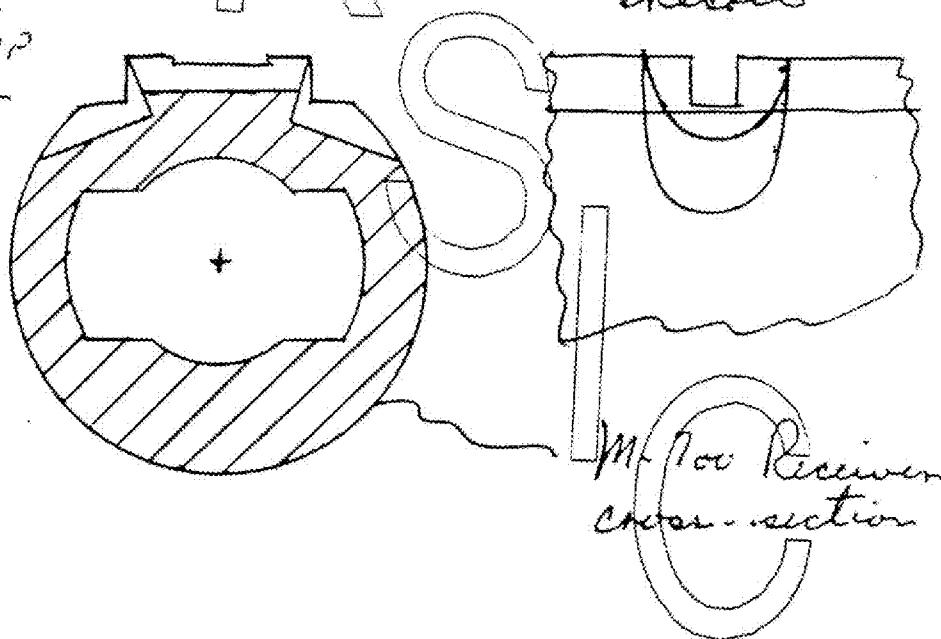
Cuts in Top
of Receiver

Slot to take
Recoil

The scope ring designed for use with this system has to clamp to engage the angles recessed in the receiver and a lug to engage the slot.

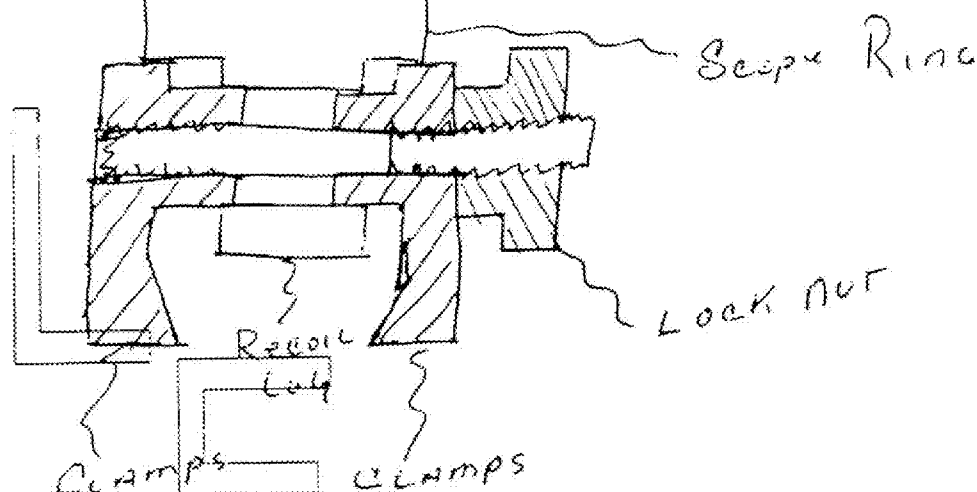
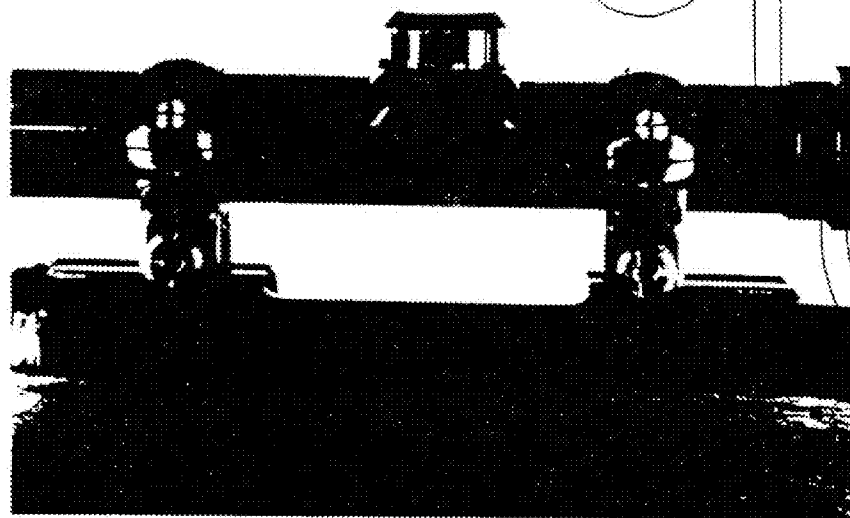
Integral Scope Mounts (Continued)

A variation of this system would be to have only one moveable clamp.

The picture shows the system mounted on a Remington Bolt Action Rifle.

An advantage of this system is that should the individual ~~with~~ want to remove the scope he can unscrew the clamp, replace it with no change in sight occupancy.

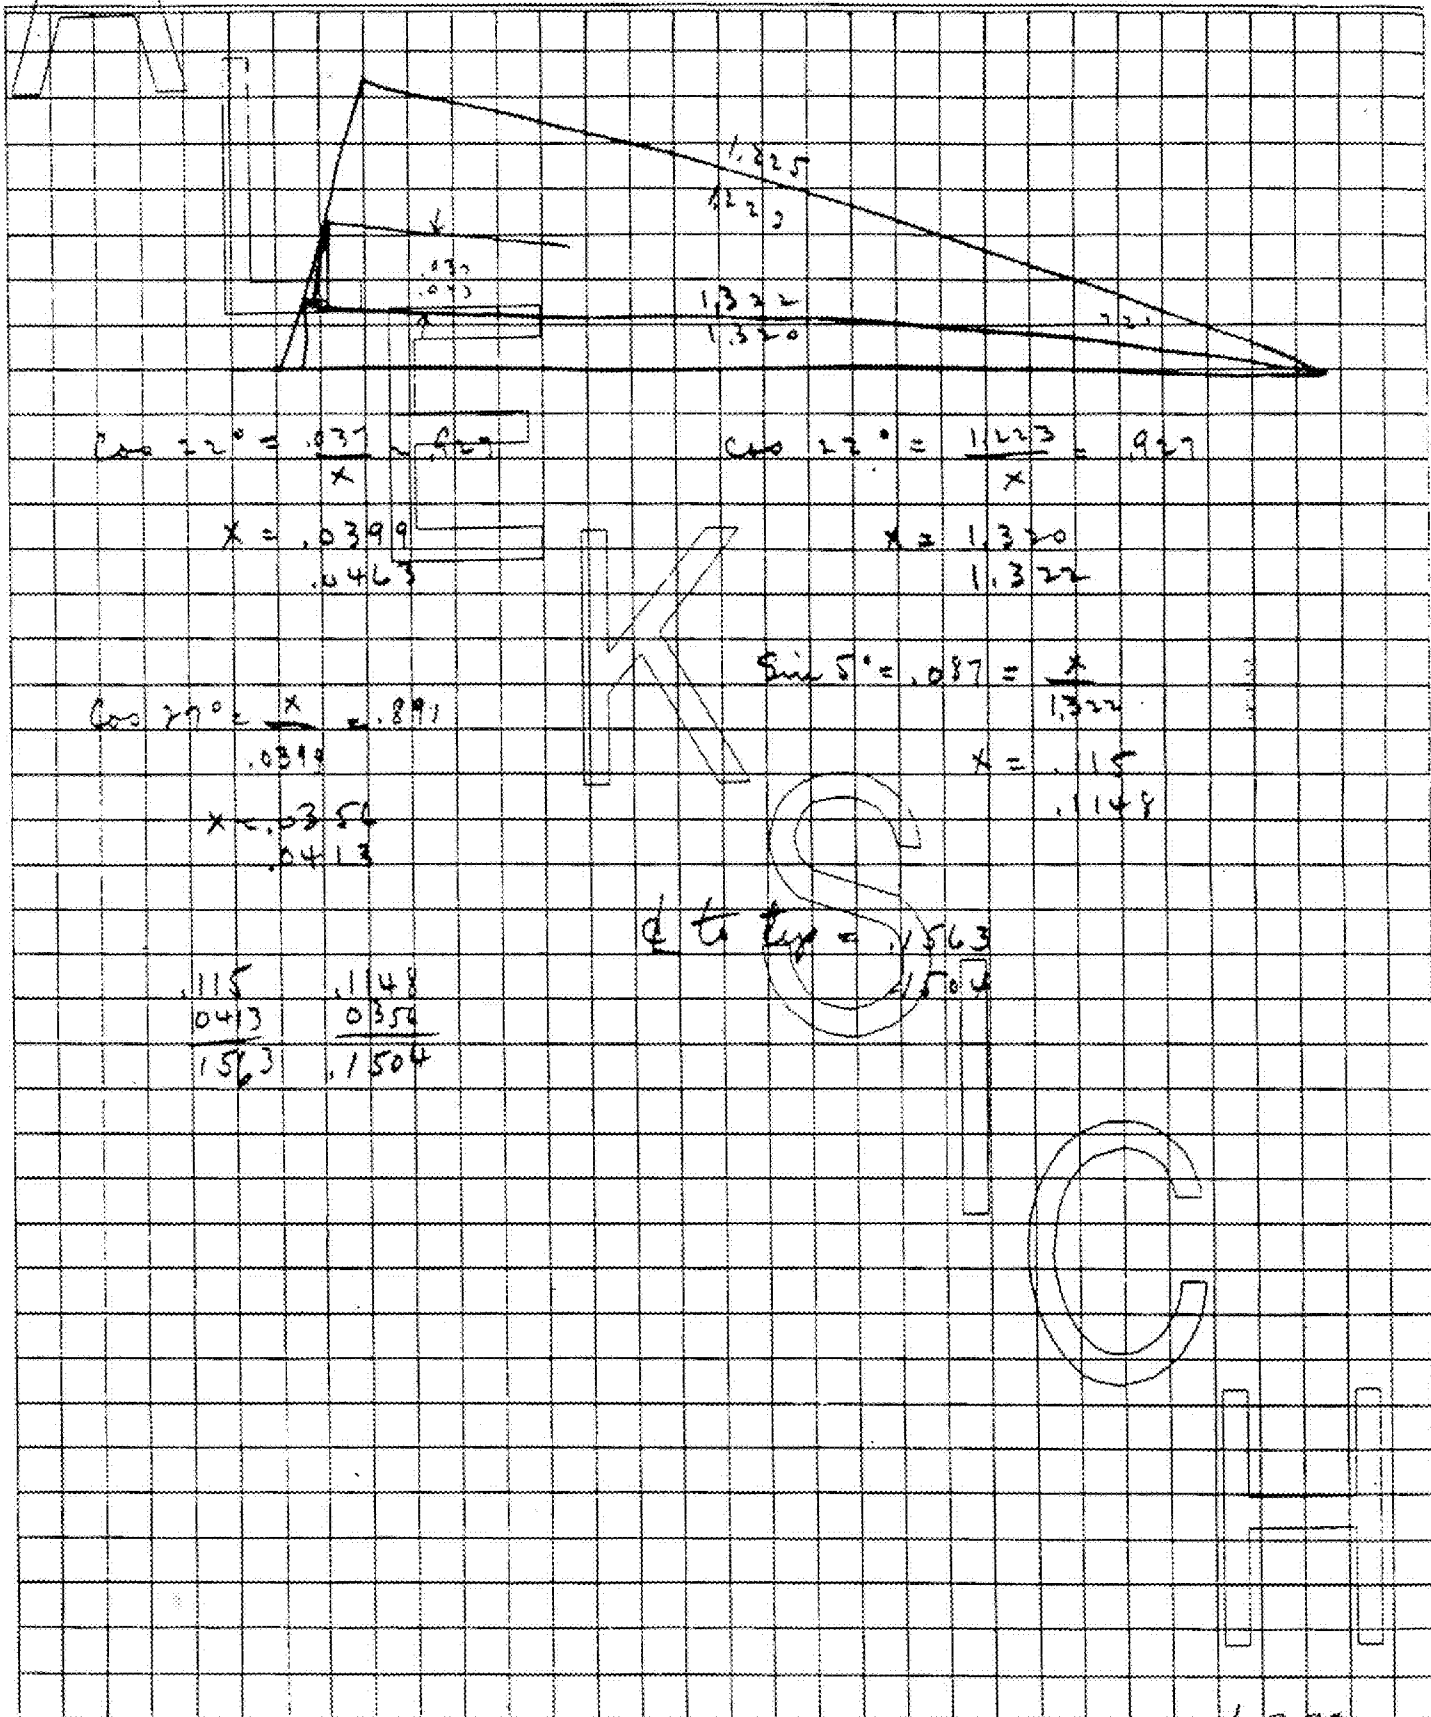
$$\cos 22^\circ = \frac{0.37}{x} = 0.927$$

$$x = \frac{0.37}{0.927} = 0.400$$

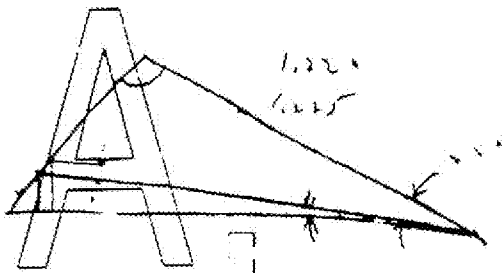
$$\cos 22^\circ = \frac{1.220}{x} = .9272$$

$$x = 1.316$$

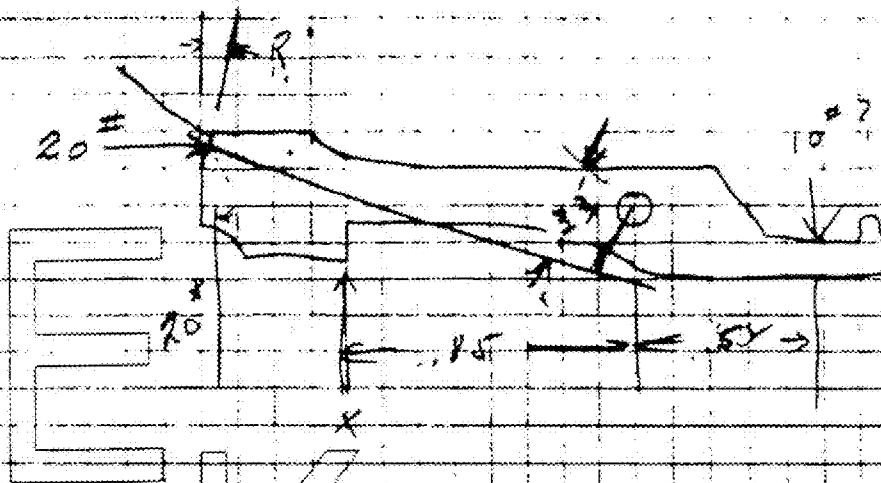
Blocked semi trigger

$$(10) .52 < 24 (.33)$$

$$5.2 < 8$$

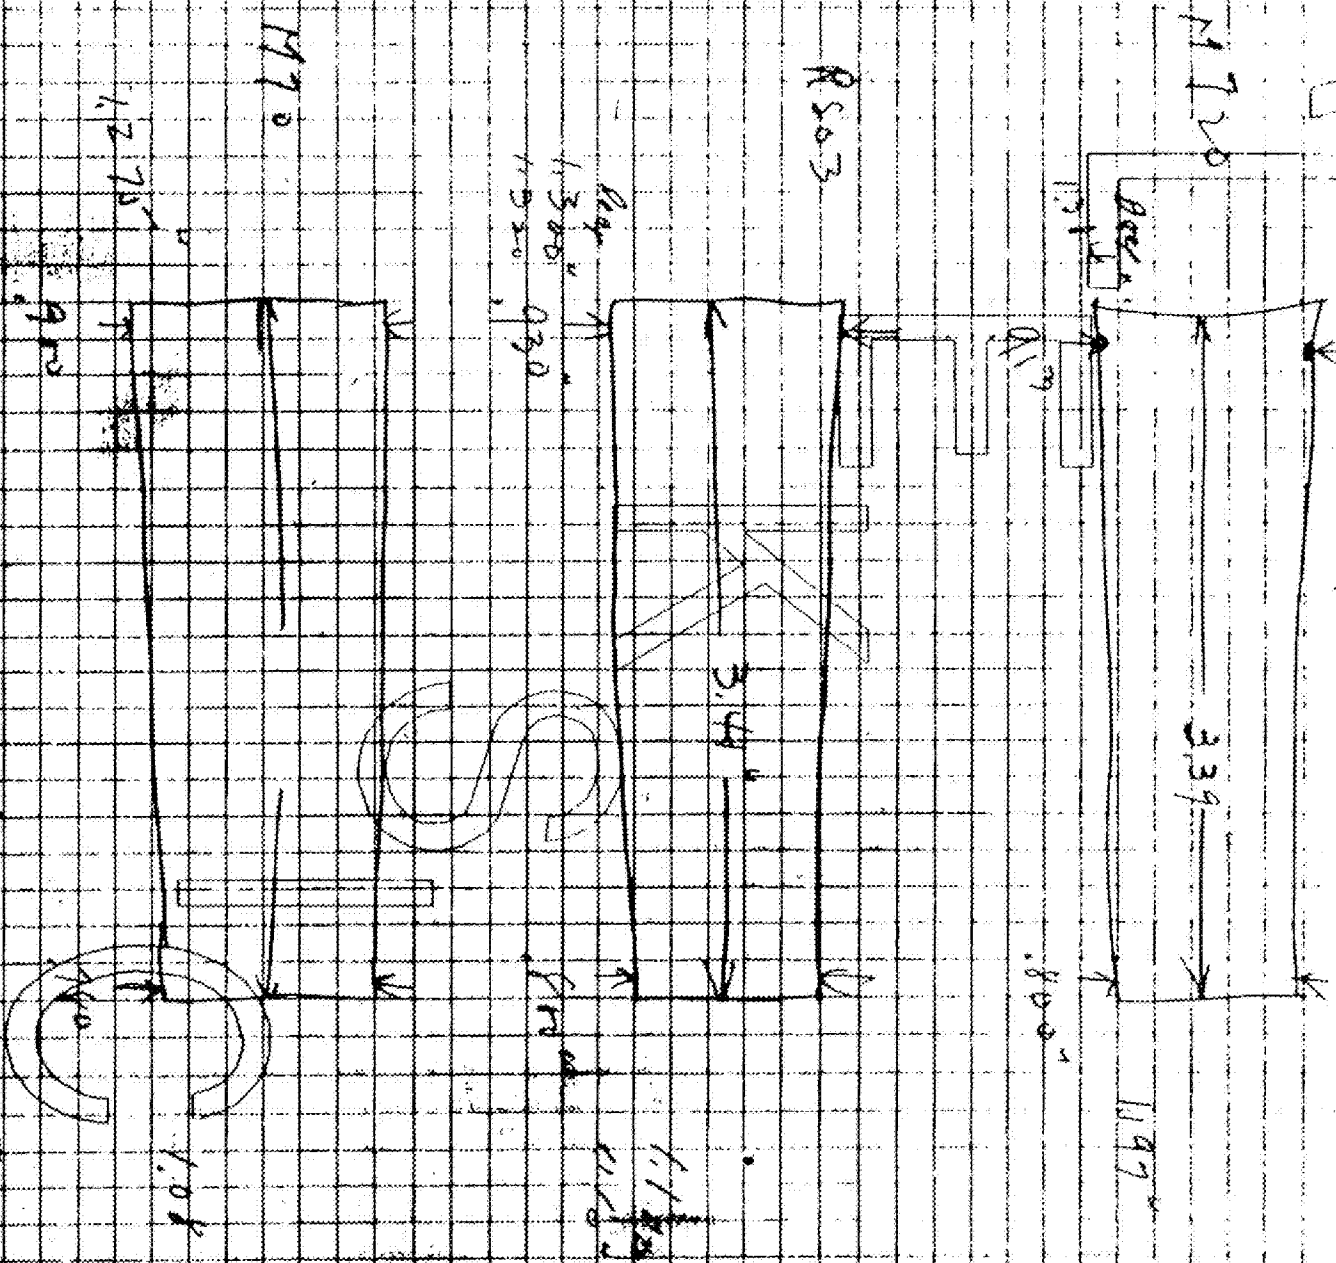
3 o.s. & 1 m.s. pyrogon

Outline of working part

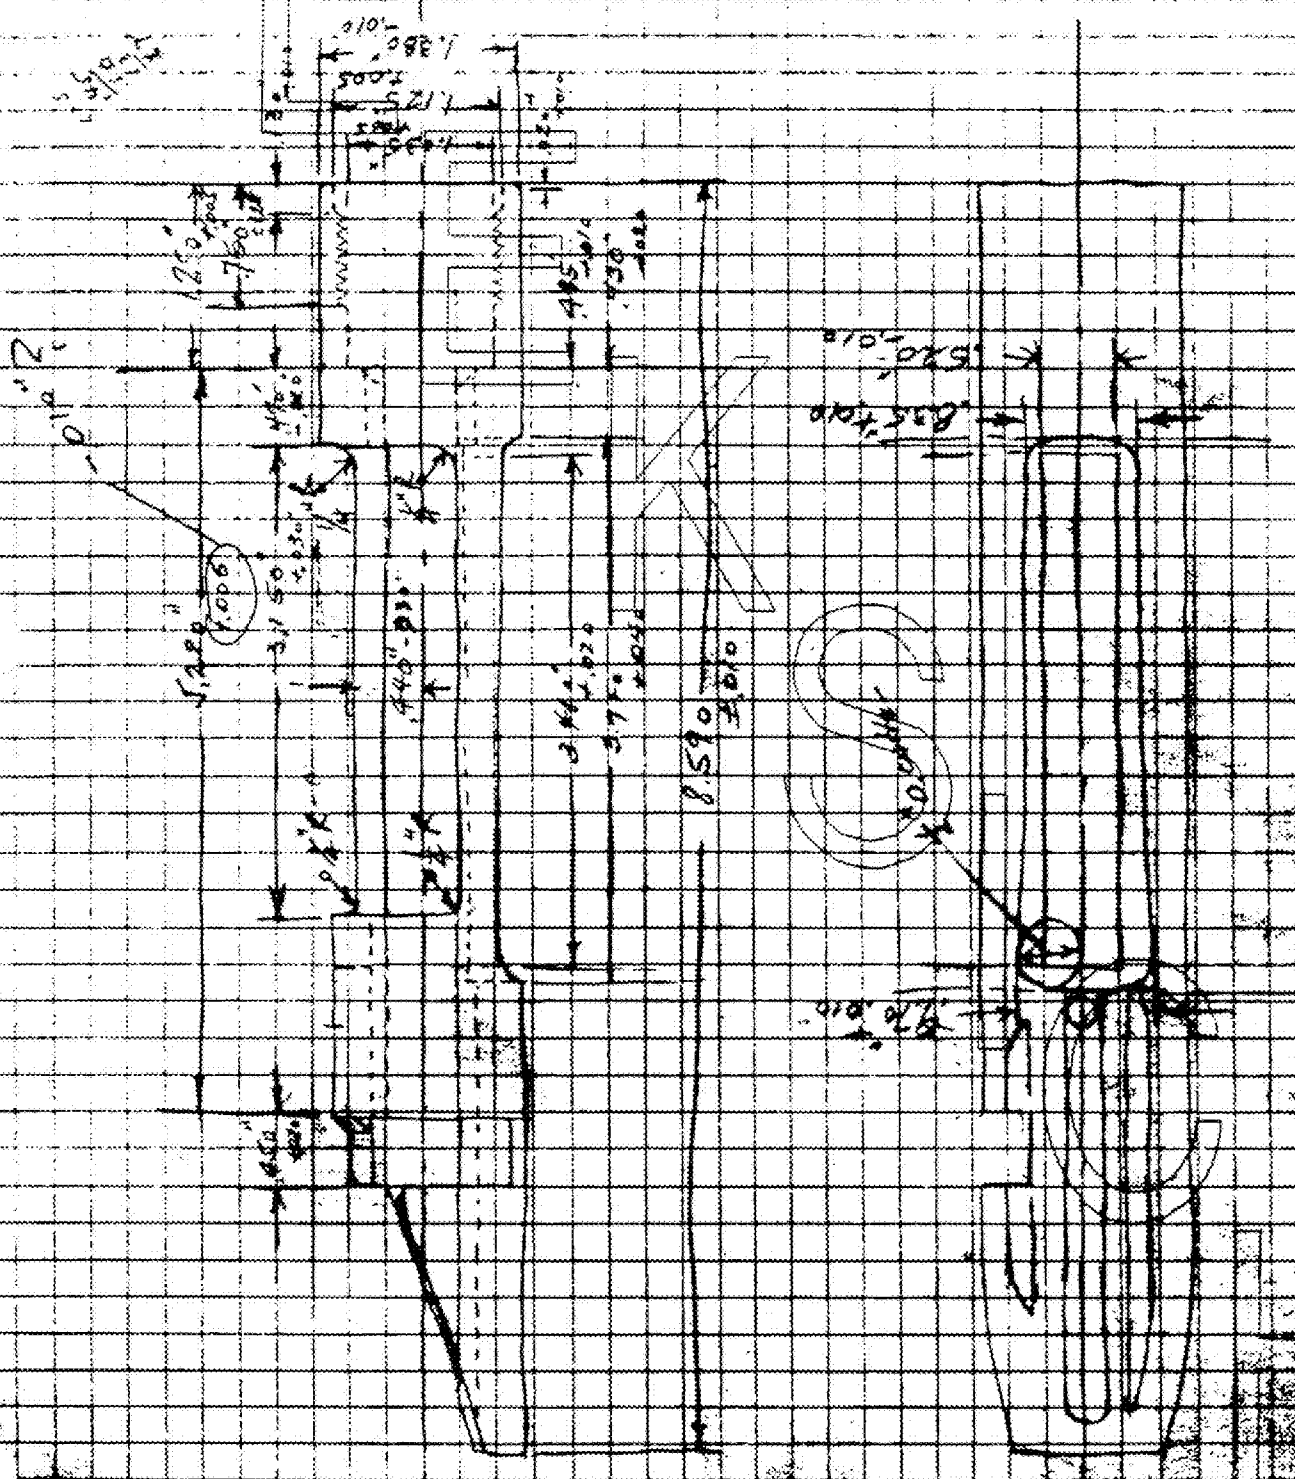
721 Reamer Dimensions

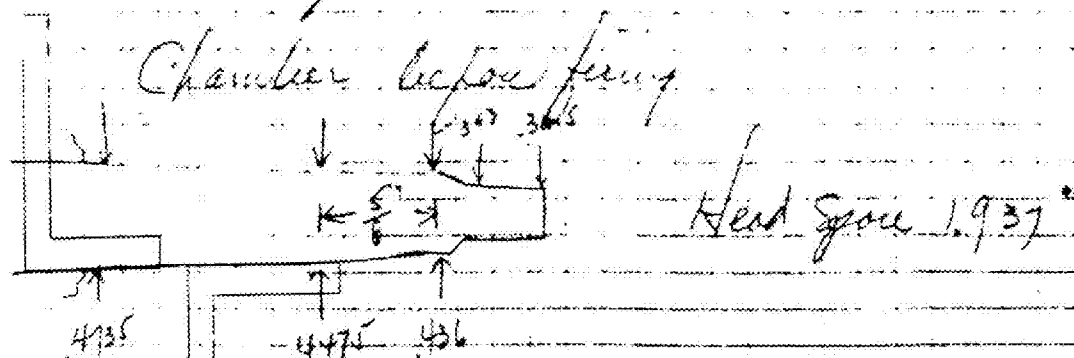
First cartridge Fired on 11/7/37

A standard 30.06 Rem. U.S. S.P. was fired after some trouble getting the indent up to .018. The case stretched in front of the solid head and ruptured enough to let out some gas. The primer was smeared to more than $\frac{1}{4}$ " diameter.

It is fairly evident that the loading plug took up on the body instead of the shoulder of the chamber causing these head space.
