E. I. du Pont de Nemours & Company
(Incorporated)

SUBJECT USE OF DU PONT OVAL TRADE-MARK BY
REMINGTON ARMS COMPANY, INC.

A Manual
for the Standard Use
of the Company Name,
Trademark, and Slogan

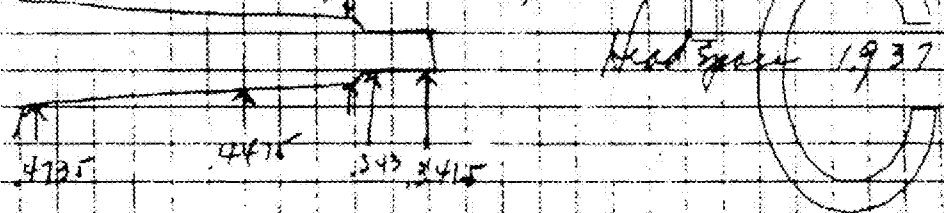
Chamber after firing

No Swell is evident.

It is fairly evident that the loading plug took up on the body instead of the shoulder of the chamber causing these head space.

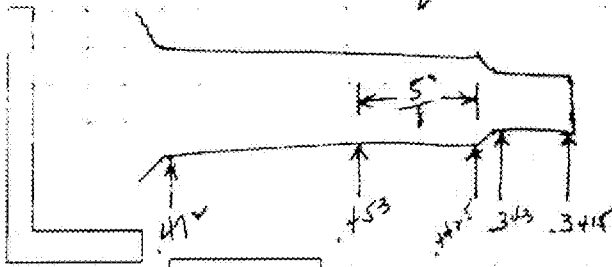
First Cartridge in 721 after reheading
Before Firing

Head Space
1.957

No change in case diameter after 10 prop/loads

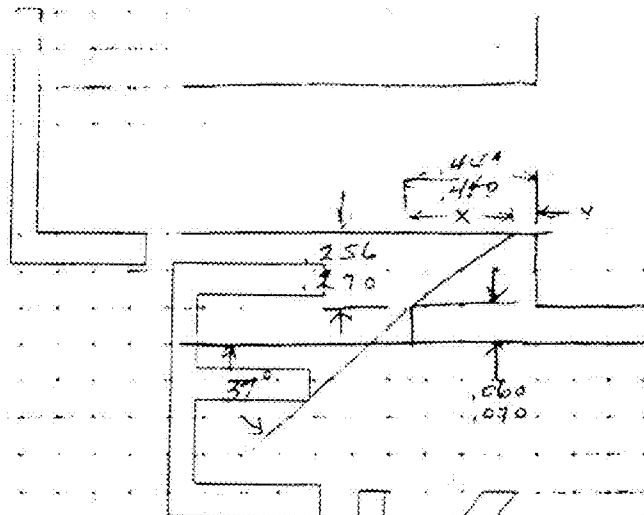
CARRIAGE RAMP

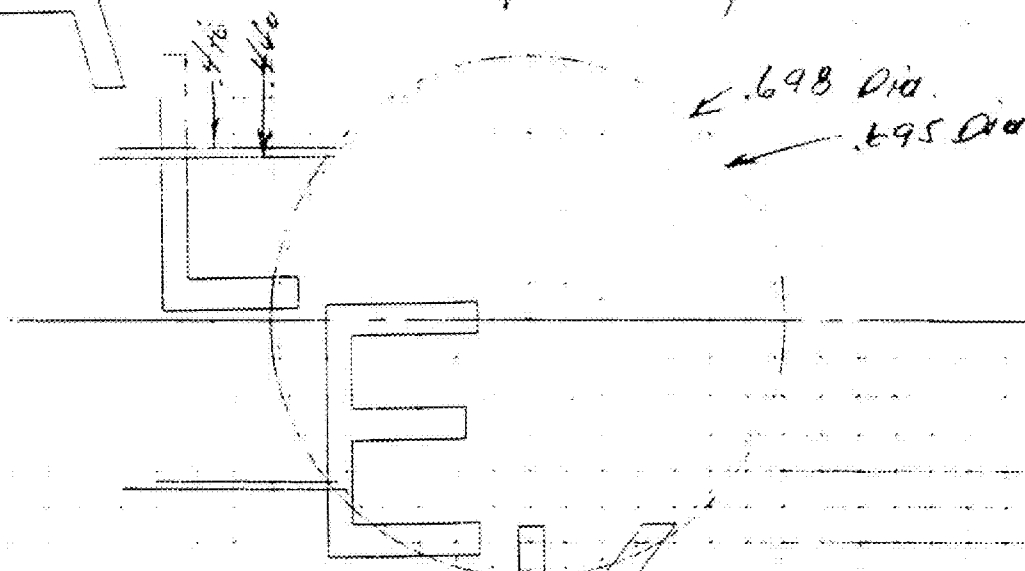
Bolt Body and Log Intersection

← .698 Dia.

← .695 Dia.

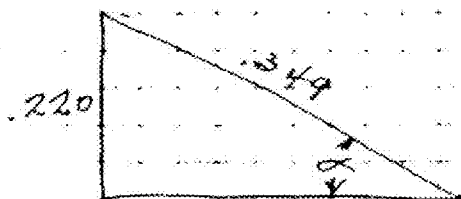
MIN. LUG & MAX BOLT

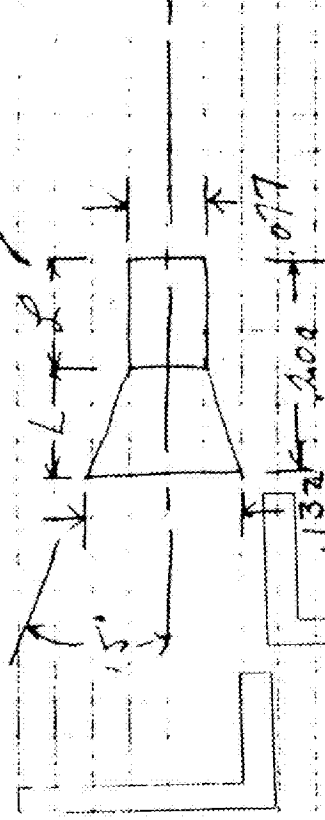
7-14-44
Bolt Head - Spring Saw

Find Min L

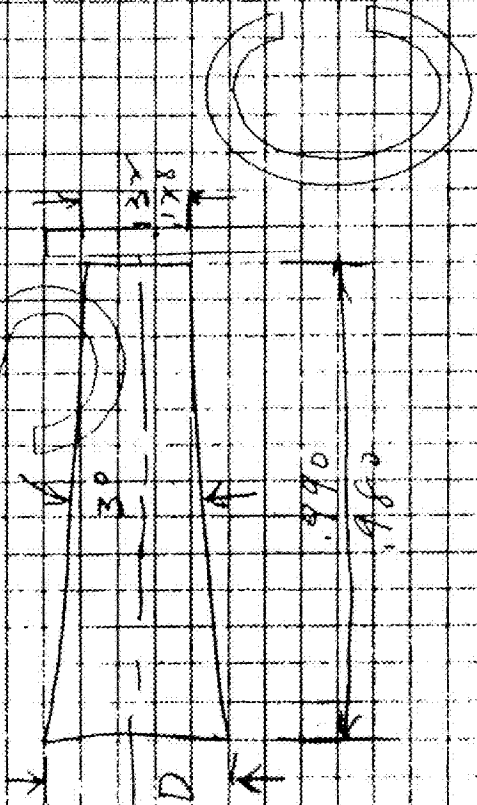
Find Max & Min D

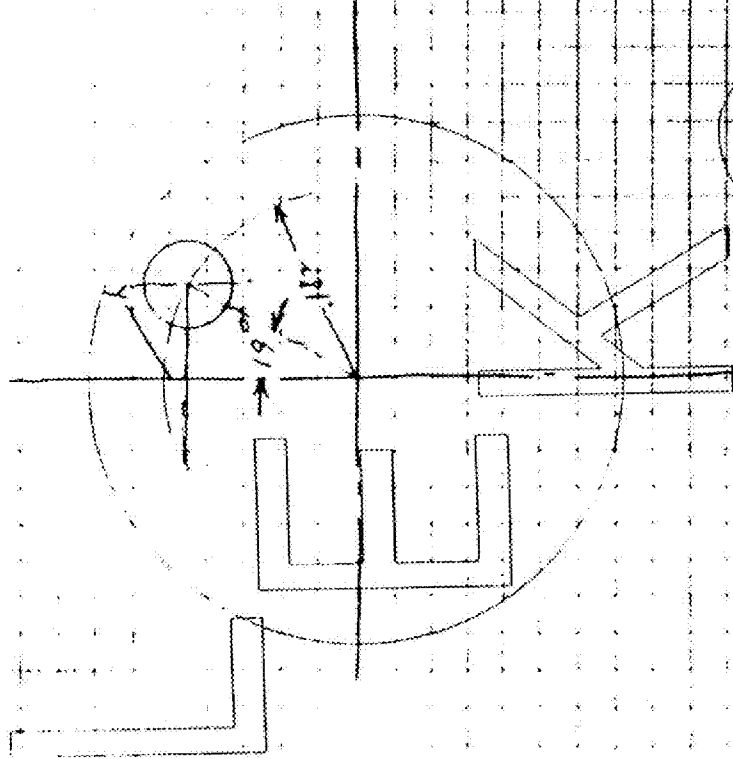
Placement of gyator pin hole

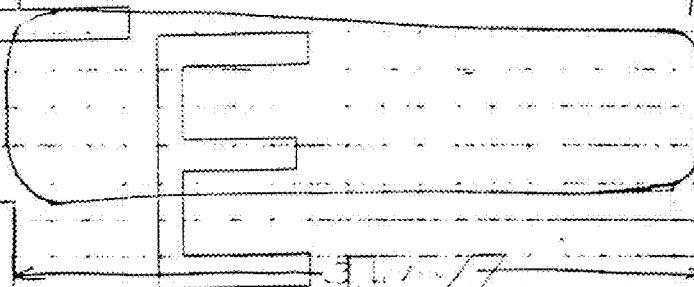
300 H-4 Follower

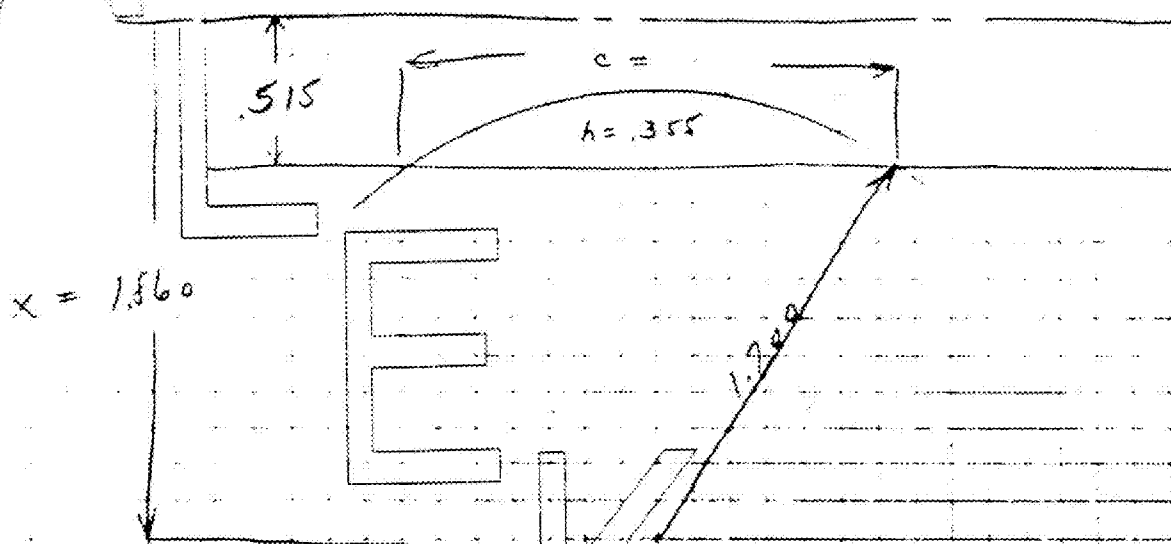
Calculations of cutter centers for Fine control

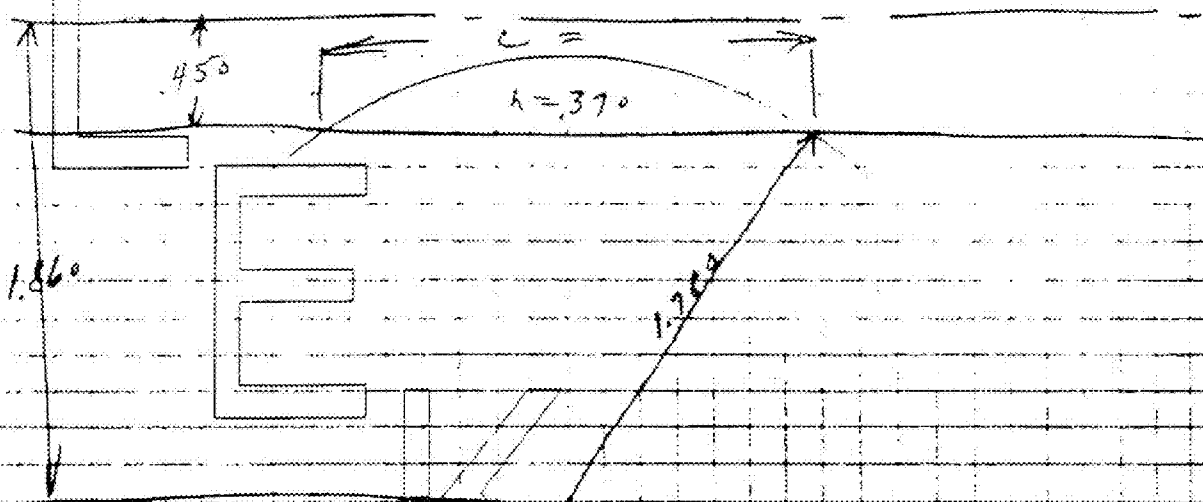
Cutter centers

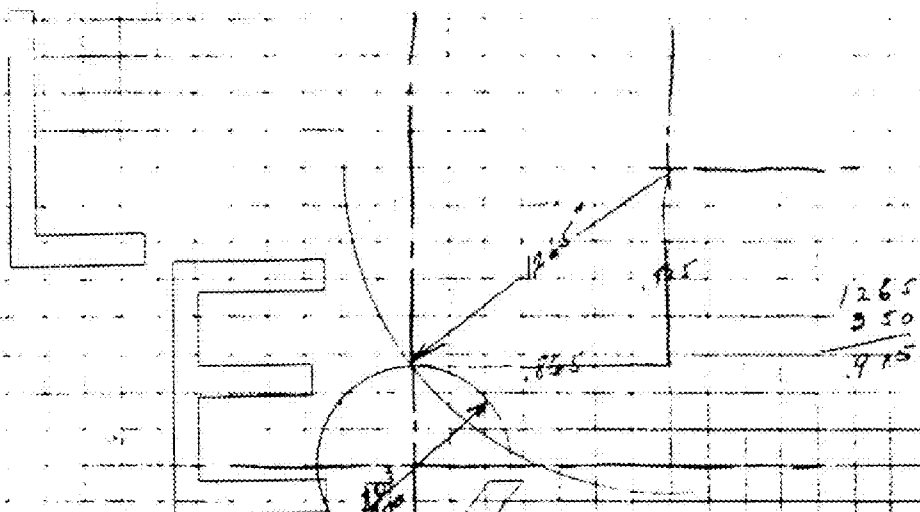
Extraction from Carter Center

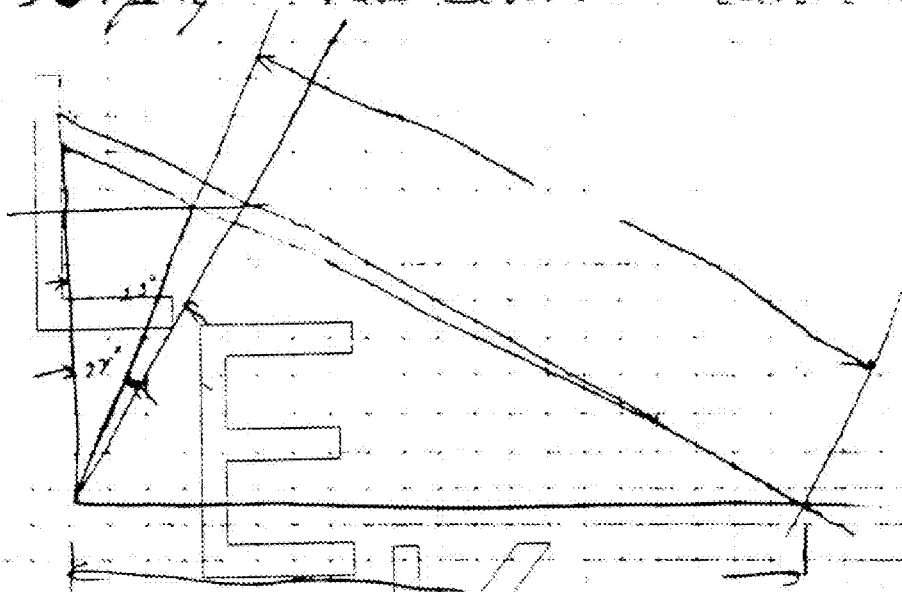
Safety of Fire Control Characteristics (Cont.)

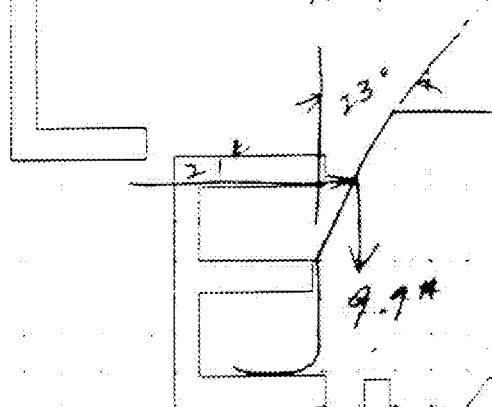
Calc on old sec + Safety

4.3/1 = ADVANTAGE

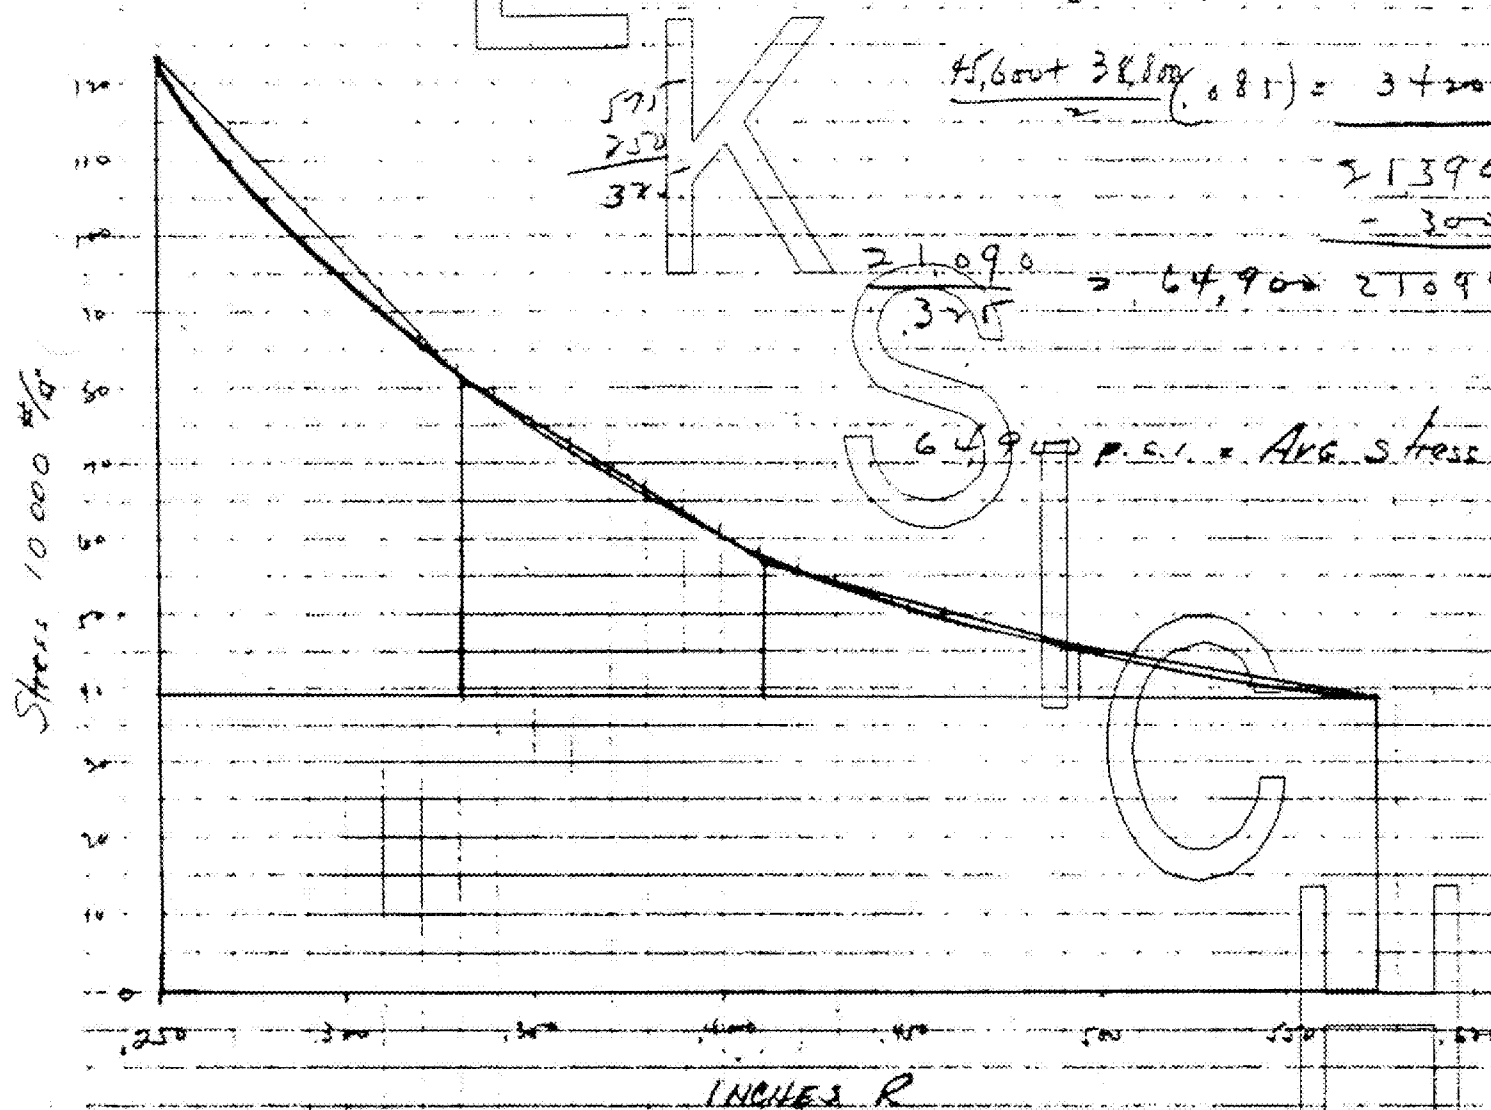
64,900 p.s.i. = Avg. stress

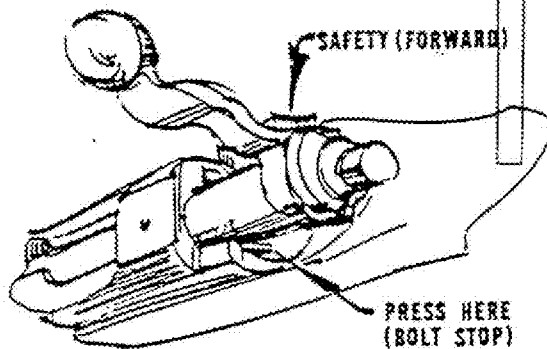
A. Pull Bolt rearward until Bolt Stop halts Bolt.

B. Insert small tool against Bolt Stop and press downward. This will release Bolt. (See Figure below)

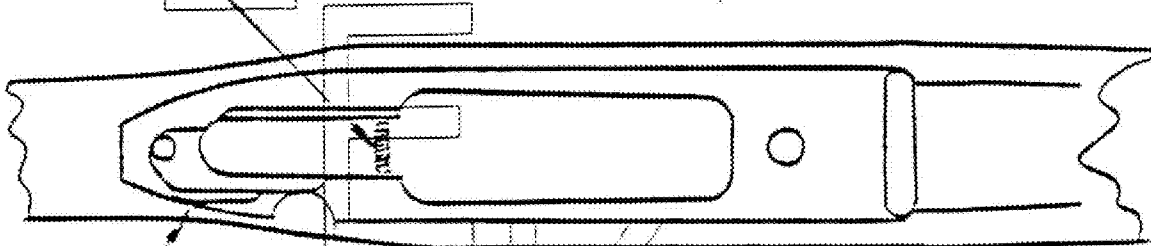
- A. Bend screw forward .050" max.
- B. If interference remains or the screw breaks, remove exposed stock reinforcing screw section and file flush with interior walls of stock.

Possible interference point with
trigger housing assembly

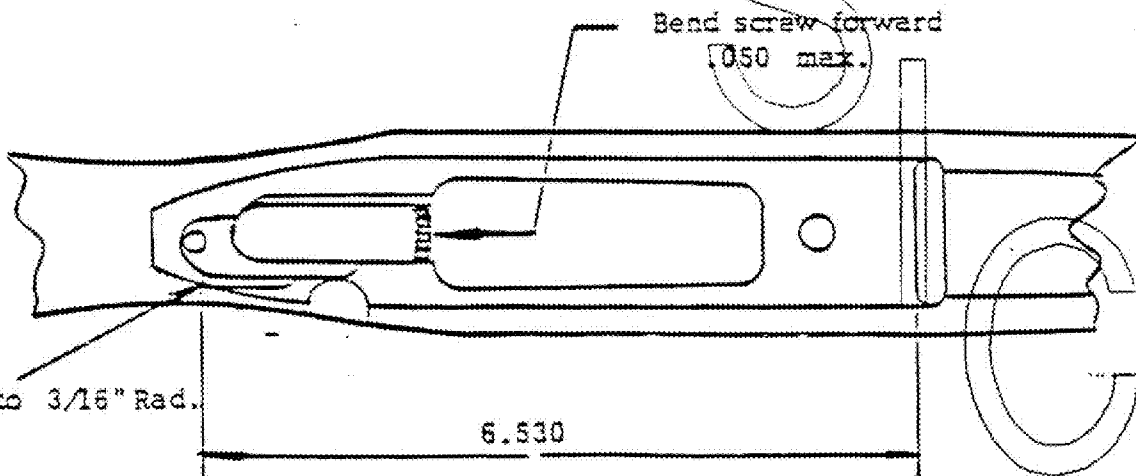
Safety arm operation must be free & clear of stock.

1/8" to 3/16" Rad.

6.530

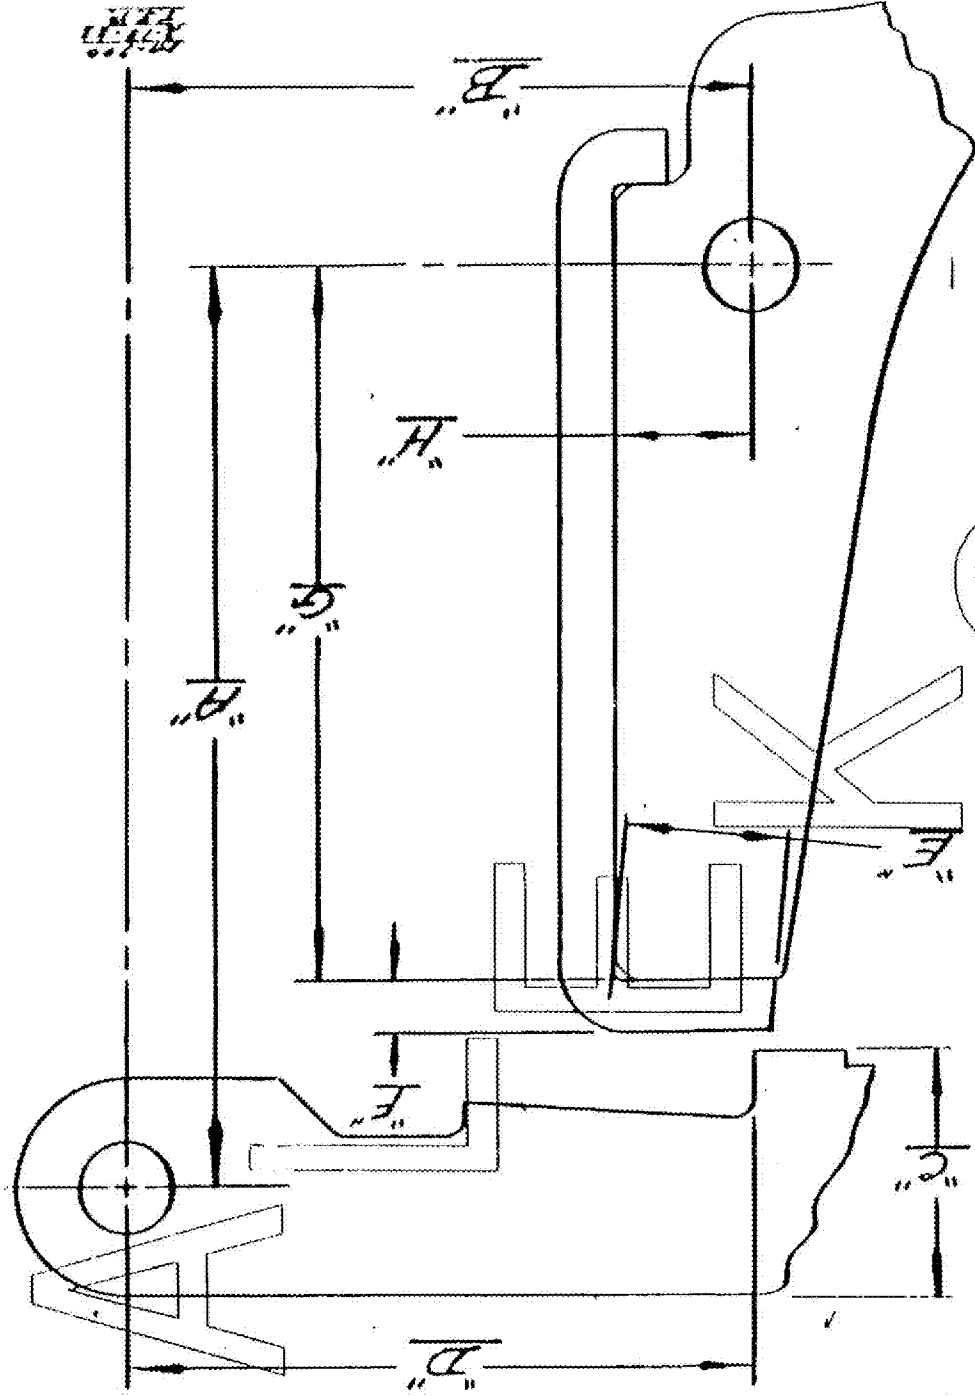
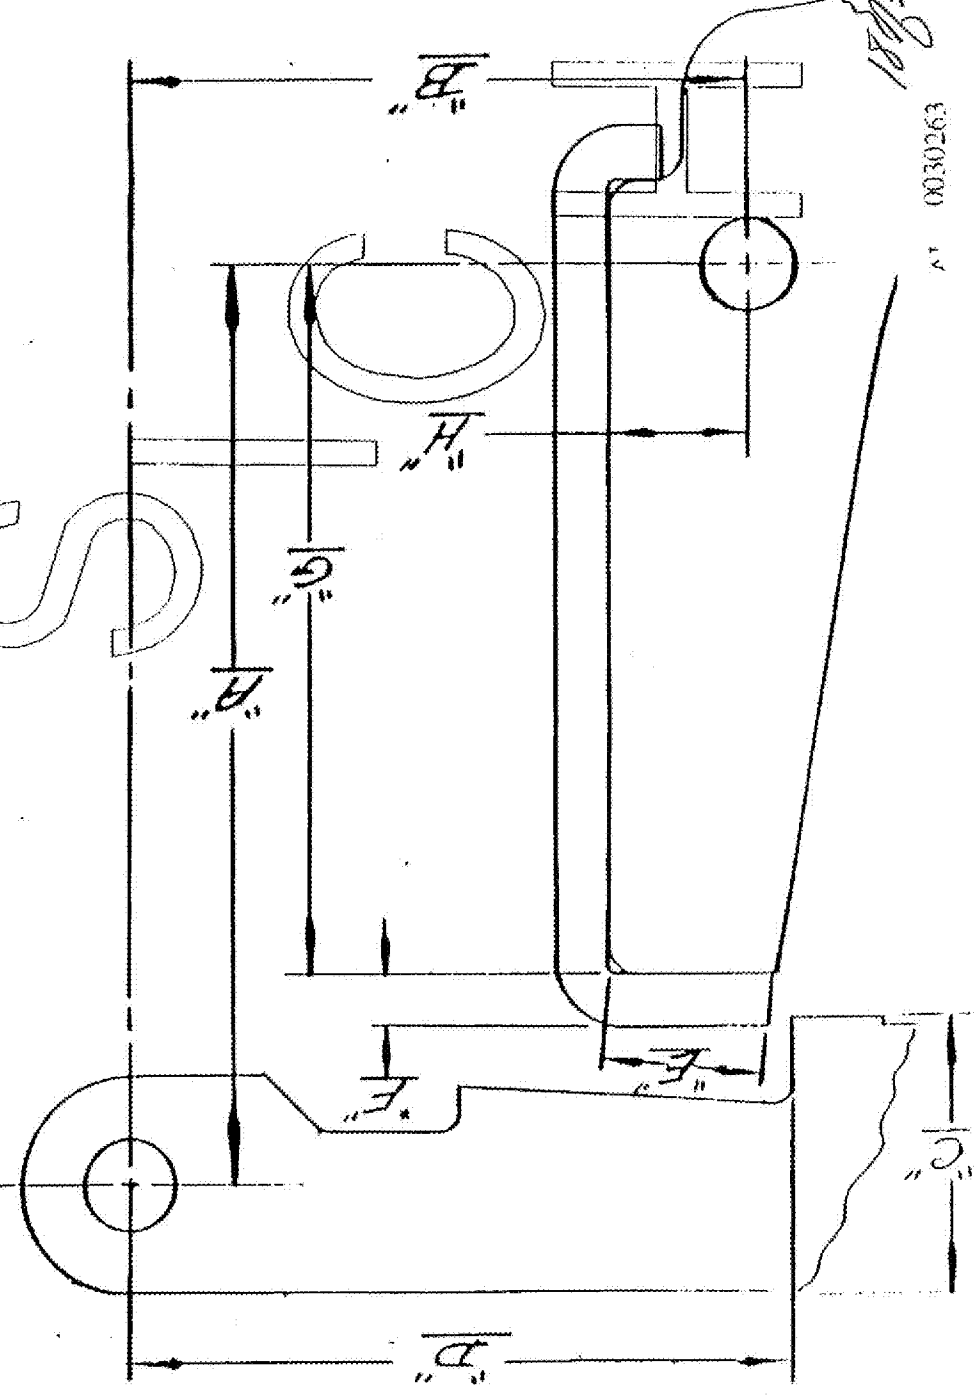
"APPENDIX "A"

CONDITION NO.		1	1	1	2	2	2	1	2	2	1	1	2
TRIGGER HOUSING ASSEMBLY NO.		①	②	③	④	5	⑥	7	8	⑨	10	⑪	12
	Dim.												
HOUSING	A	1.2395	1.2385	1.2395	1.241	1.2405	1.240	1.2385	1.2385	1.2405	1.240	1.238	1.2395
	B	.8395	.839	.8395	.841	.8415	.841	.840	.8405	.8405	.8385	.839	.842
GEAR	C	.1975-.198	.1975-.198	.1975-.198	.186	.1865	.1865	.1975	.1855	.1855	.1975	.1975-.198	.1865
	D	.8705-.871	.870-.8695	.8705-.871	.8655	.8655	.8645	.870-.8695	.863	.865	.871	.869-.8695	.8645
CONNECTOR	E	.215	.215	.215	.225	.225	.225	.215	.225	.225	.215	.215	.225
	F	.074	.072-.0715	.071-.0705	.071	.071	.071	.074	.071	.071	.074	.072-.0715	.071
TRIGGER	G	.972	.975	.975	.967	.967	.967	.9725	.967	.967	.9725	.975	.967
	H	.190	.190	.190	.186	.186	.186	.190	.186	.186	.190	.190	.186
		B6440172	B6440199	B6440277	B6438163		B6439730			B6438686		B6440458
