Remington Arms Company, Inc.

September 12, 2000

RE: M/710 MAGAZINE BOX SPOT WELD STRENGTH TEST COMPARISON OF DAT BOXES TO PRODUCTION BOXES

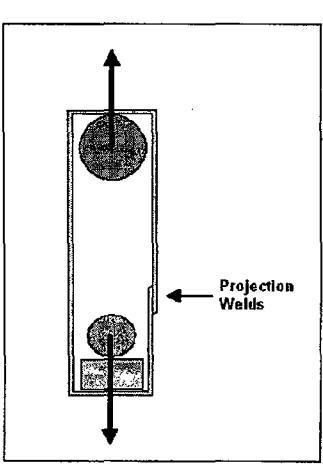
Figure 1. Illustration of the test set-up. Looking at the top of the magazine box cross-section.

The block was placed at the front of the magazine box to prevent the box from distorting during the tensile testing. The total force required to fail the box was reported from the Instron load cell. The shear strength per weld was calculated by dividing the total force by 4 (divide by 2 to determine the force per side then divide by 2 again to determine the force per weld (2 welds on 1 side of the box)).

A total of five magazine boxes were presented for testing. Three were current DAT samples and two were current production samples. The samples were labeled as DAT 1, DAT 2, DAT 3, PROD 1, and PROD 2. DAT 1 was destroyed during the test set-up and no usable data was recorded. The other boxes, however, were all tested successfully using the set-up described. The magazine boxes were fixtured into the Instron tensile testing machine using a small block and two pins. Figure 1 presents an illustration of the testing set-up.

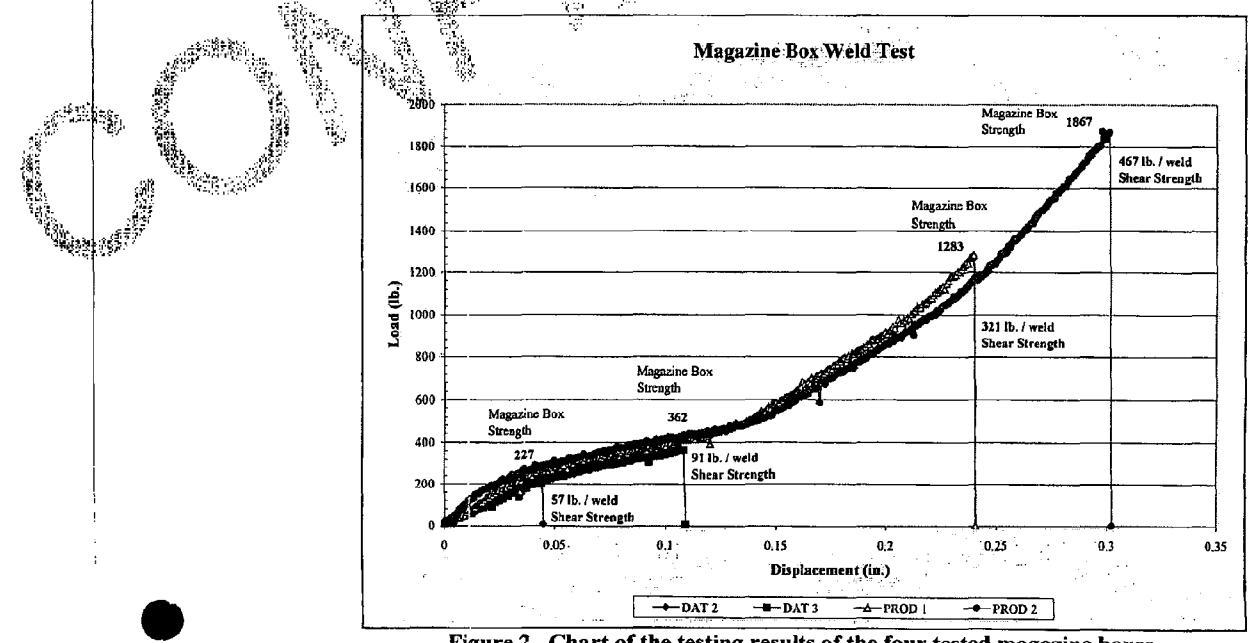
Figure 2 shows a graphical presentation of the data collected for all four of the tested samples. The testing results form the conclusion that the production boxes are much stronger than the DAT sample magazine boxes. The DAT boxes should be replaced with current production boxes as soon as they are available for test. -28

Figure 2. Chart of the testing results of the four tested magazine boxes.

The results of the shear strength testing show a large discrepancy between the DAT boxes and the current production boxes. Figure 2 (procedure section) presents the weld shear strength and the magazine box breaking strength for each of the tested samples in graphical form.

Based on these findings, the results show at least a 3X strength difference in shear strength when comparing the DAT magazine boxes to the current production magazine boxes. It is recommended that the DAT magazine boxes in test be replaced with current production magazine boxes and the welding parameters of these replacement boxes be documented.
