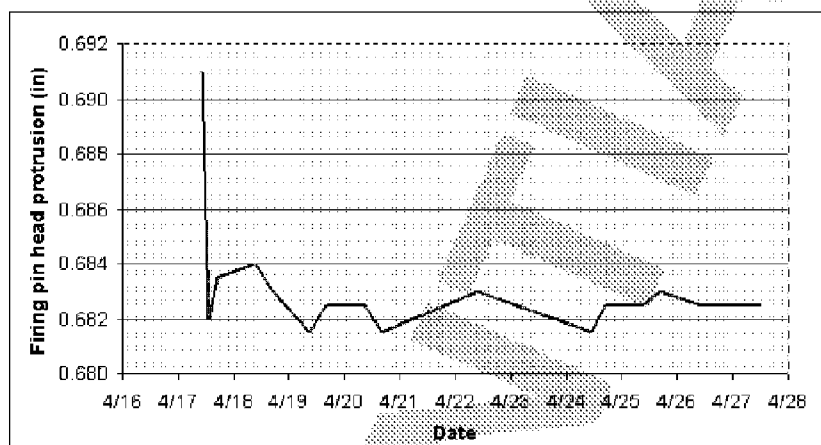
Figure 6. Firing pin protrusion over creep test duration.
