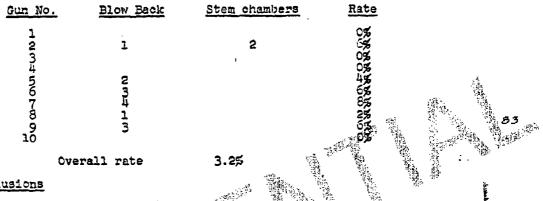
Assuming that the above M/552 had over 1,000 rds. fired, including gallery test, question arose that this amount of firing would help to break in these guns. Therefore, the above picture might be erroneous. Ten more M/552s were secured from warehouse and the above test repeated, with these results showing a reduced rate.

To date the N/552 appears to be a better performing gun than the N/550. The high rate of performance of the M/550 is alarming, particularly if this quality of guns is reaching the field. The N/552 will not adequately handle the standard shorts and is questionable on high speed shorts in told weather. The firing pin breakage is being investigated. It is recommended that the fullure to extract in unloading live annunition be investigated. Firther endorse Lest will follow.
