The Remington 700 Gets a New Trigger

After decades, new fire control graces the 700 line.

Jon R. Sundra

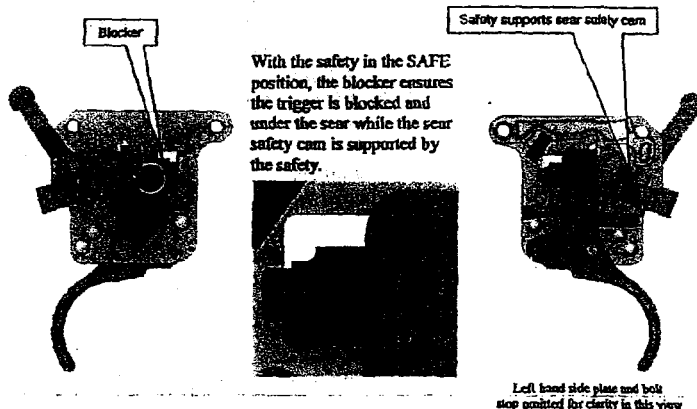
Safety in SAFE Position

the original, but differs in one major element: the safety blocks movement of both the trigger and sear. All past 700's (and the predecessor Model 721/722 series dating back to 1948), have a safety that, when engaged, blocks movement of the sear, but

allows the trigger to move through its normal arc when pulled. With this type arrangement, if the trigger is pulled with the safety on, it must return to its original position to support the sear.

The problem with this design is that if for any reason the trigger does not

return to its forward position, the gun can discharge when the safety is released. There are several scenarios under which this can happen, but primarily it occurs when there is friction against the trigger — like if the barreled action is canted in the stock slightly so the trigger is dragging against either side of the cutout in the top of the trigger guard bow. Another cause could be swelling of wood in that area of the stock's inletting surrounding the trigger. That can be caused by high humidity, soaking rain or wet snow. I have personally seen both these conditions occur on rifles with triggers similar to that of the Remington. I was also present when a colleague released the safety on an older Tikka and the gun fired. That incident was caused by a Styrofoam bead from the original factory box that had somehow gotten into the trigger unit and wedged itself in such a location that the trigger could not return to its forward position.

The new SPL trigger blocks both trigger and sear movement, while still allowing the action to be cycled when engaged. Remington makes several claims for the new trigger, among them:

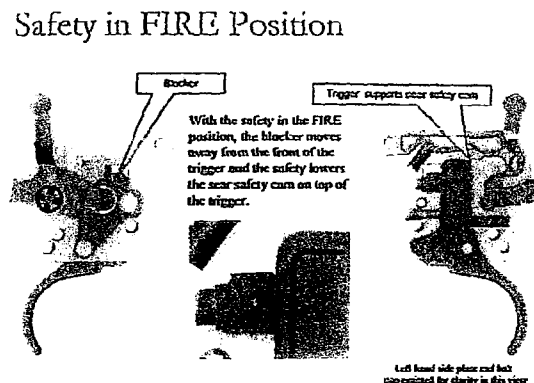
This diagram illustrates how the safety of the new Remington 700 trigger operates in the firing position.

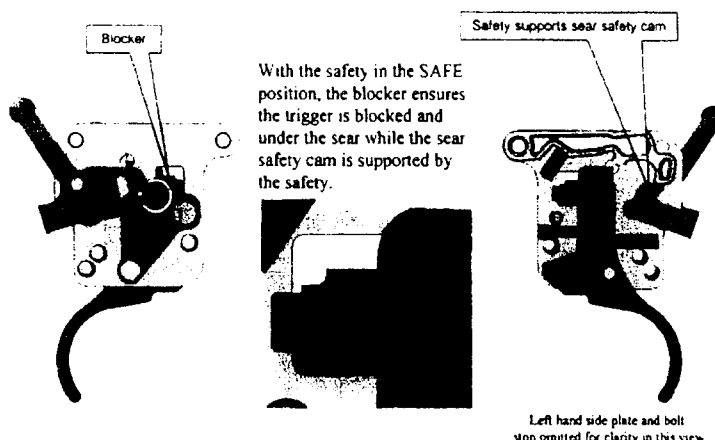
Safety in SAFE Position

the original, but differs in one major element: the safety blocks movement of both the trigger and sear. All past 700's (and the predecessor Model 721/722 series dating back to 1948), have a safety that, when engaged, blocks movement of the sear, but

allows the trigger to move through its normal arc when pulled. With this type arrangement, if the trigger is pulled with the safety on, it must return to its original position to support the sear.

The problem with this design is that if for any reason the trigger does not

return to its forward position, the gun can discharge when the safety is released. There are several scenarios under which this can happen, but primarily it occurs when there is friction against the trigger — like if the barreled action is canted in the stock slightly so the trigger is dragging against either side of the cutout in the top of the trigger guard bow. Another cause could be swelling of wood in that area of the stock's inletting surrounding the trigger. That can be caused by high humidity, soaking rain or wet snow. I have personally seen both these conditions occur on rifles with triggers similar to that of the Remington. I was also present when a colleague released the safety on an older Tikka and the gun fired. That incident was caused by a Styrofoam bead from the original factory box that had somehow gotten into the trigger unit and wedged itself in such a location that the trigger could not return to its forward position.

The new SPL trigger blocks both trigger and sear movement, while still allowing the action to be cycled when engaged. Remington makes several claims for the new trigger, among them:

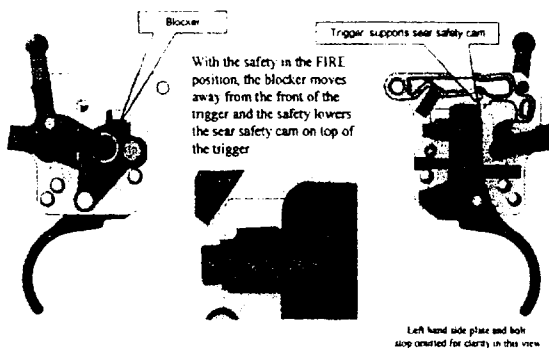
Safety in FIRE Position

This diagram illustrates how the safety of the new Remington 700 trigger operates in the firing position.

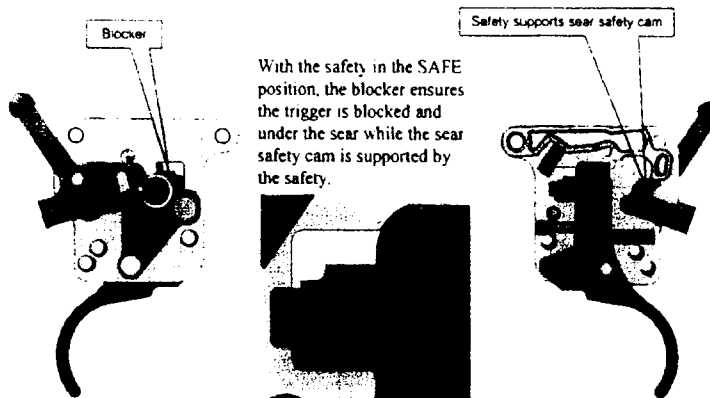
Safety in SAFE Position

the original, but differs in one major element: the safety blocks movement of both the trigger and sear. All past 700's (and the predecessor Model 721/722 series dating back to 1948), have a safety that, when engaged, blocks movement of the sear, but

allows the trigger to move through its normal arc when pulled. With this type arrangement, if the trigger is pulled with the safety on, it must return to its original position to support the sear.

Left hand side plate and bolt stop omitted for clarity in this view

return to its forward position, the gun can discharge when the safety is released. There are several scenarios under which this can happen, but primarily it occurs when there is friction against the trigger — like if the barreled action is canted in the stock slightly so the trigger is dragging against either side of the cutout in the top of the trigger guard bow. Another cause could be swelling of wood in that area of the stock's inletting surrounding the trigger. That can be caused by high humidity, soaking rain or wet snow. I have personally seen both these conditions occur on rifles with triggers similar to that of the Remington. I was also present when a colleague released the safety on an older Tikka and the gun fired. That incident was caused by a Styrofoam bead from the original factory box that had somehow gotten into the trigger unit and wedged itself in such a location that the trigger could not return to its forward position.

The new SPL trigger blocks both trigger and sear movement, while still allowing the action to be cycled when engaged. Remington makes several claims for the new trigger, among them:

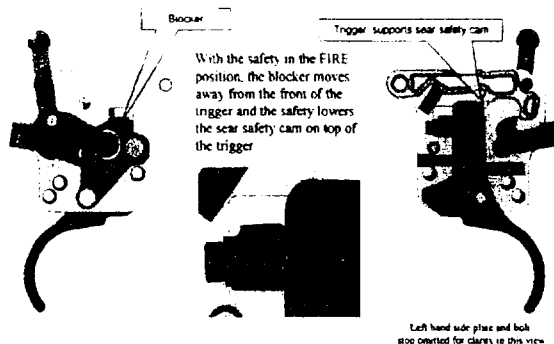
Safety in FIRE Position

This diagram illustrates how the safety of the new Remington 700 trigger operates in the firing position.

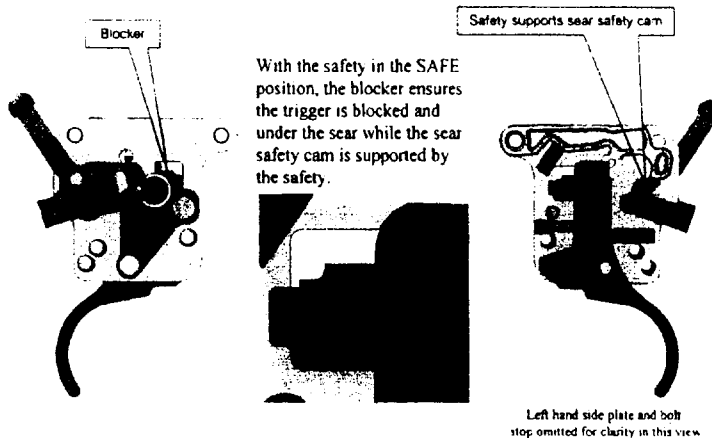
Safety in SAFE Position

the original, but differs in one major element: the safety blocks movement of both the trigger and sear. All past 700's (and the predecessor Model 721/722 series dating back to 1948), have a safety that, when engaged, blocks movement of the sear, but

allows the trigger to move through its normal arc when pulled. With this type arrangement, if the trigger is pulled with the safety on, it must return to its original position to support the sear.

The problem with this design is that if for any reason the trigger does not

return to its forward position, the gun can discharge when the safety is released. There are several scenarios under which this can happen, but primarily it occurs when there is friction against the trigger — like if the barreled action is canted in the stock slightly so the trigger is dragging against either side of the cutout in the top of the trigger guard bow. Another cause could be swelling of wood in that area of the stock's inletting surrounding the trigger. That can be caused by high humidity, soaking rain or wet snow. I have personally seen both these conditions occur on rifles with triggers similar to that of the Remington. I was also present when a colleague released the safety on an older Tikka and the gun fired. That incident was caused by a Styrofoam bead from the original factory box that had somehow gotten into the trigger unit and wedged itself in such a location that the trigger could not return to its forward position.

The new SPL trigger blocks both trigger and sear movement, while still allowing the action to be cycled when engaged. Remington makes several claims for the new trigger, among them:

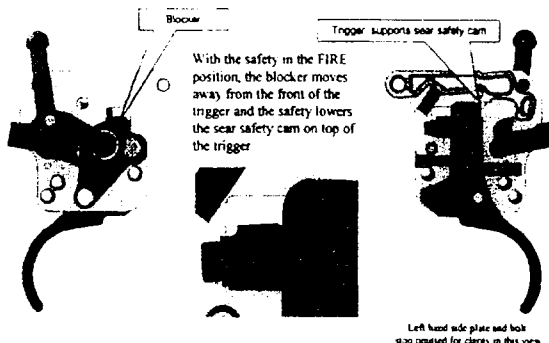
Safety in FIRE Position

This diagram illustrates how the safety of the new Remington 700 trigger operates in the firing position.
