Remington Arms Co., Inc.  
Product Service  
Legal Case #:7539

Dealer sent rifle in & stated that gun will fire on safe release. df

| Mfg. | Type | Model/Ga. | SKU | Serial | Bbl. | DOM |
|---|---|---|---|---|---|---|
| Remington | CF/BA | 700/3006 SPRG | 27319 | G6330573 | PX | 6/19/2003 9:26:33 PM |

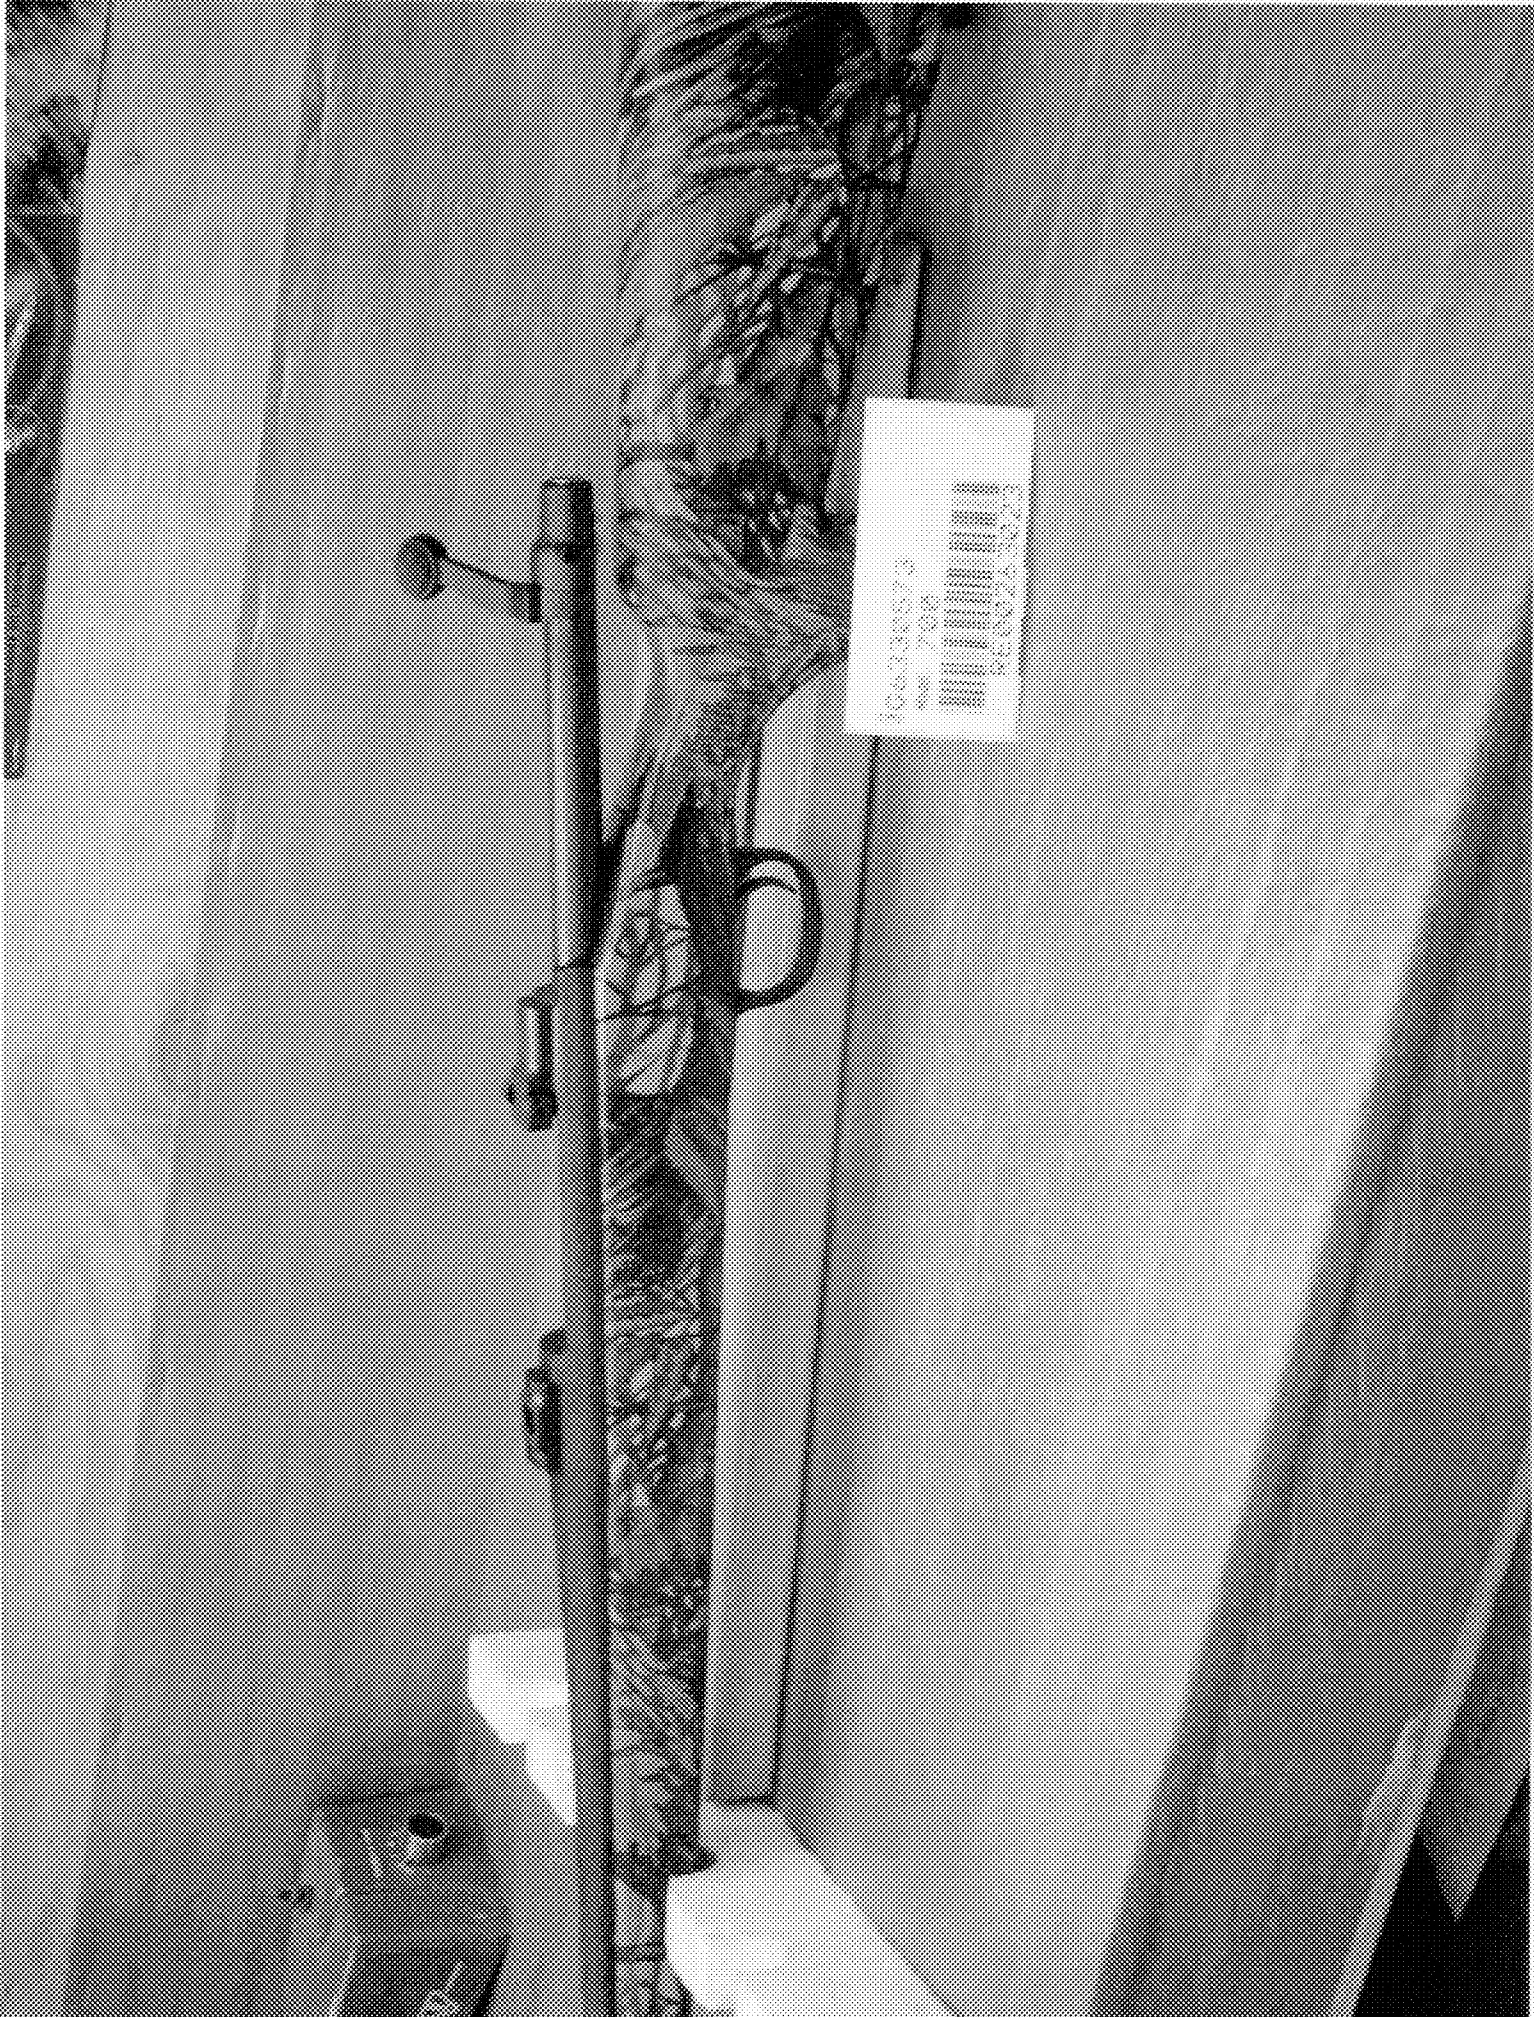
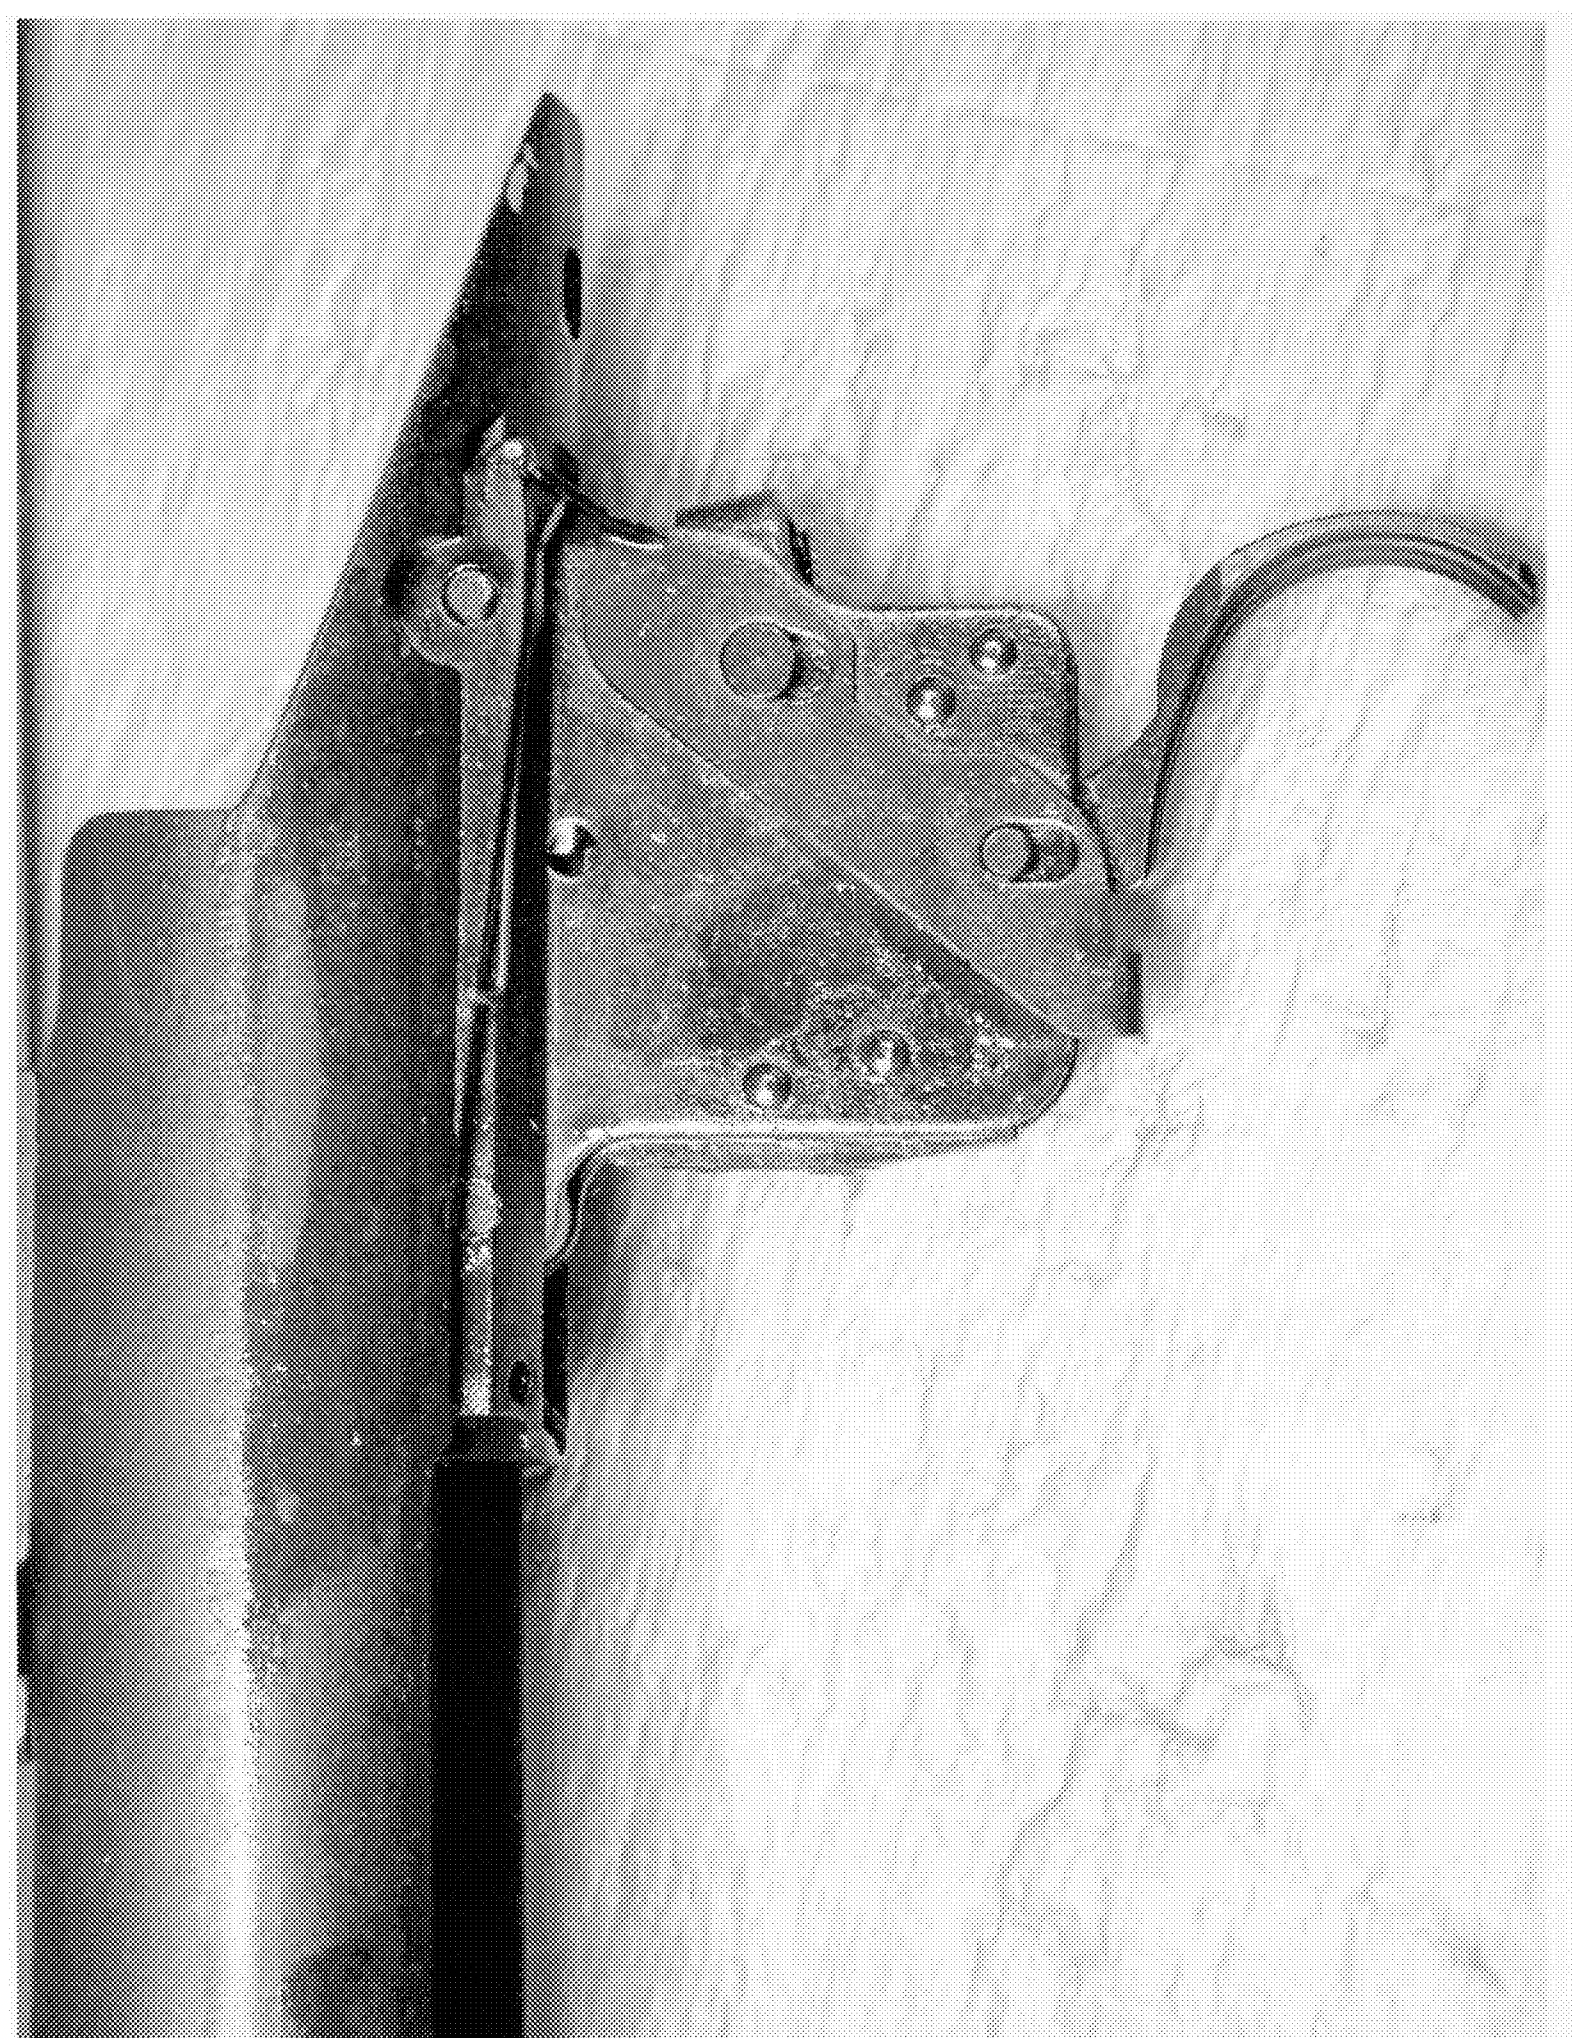
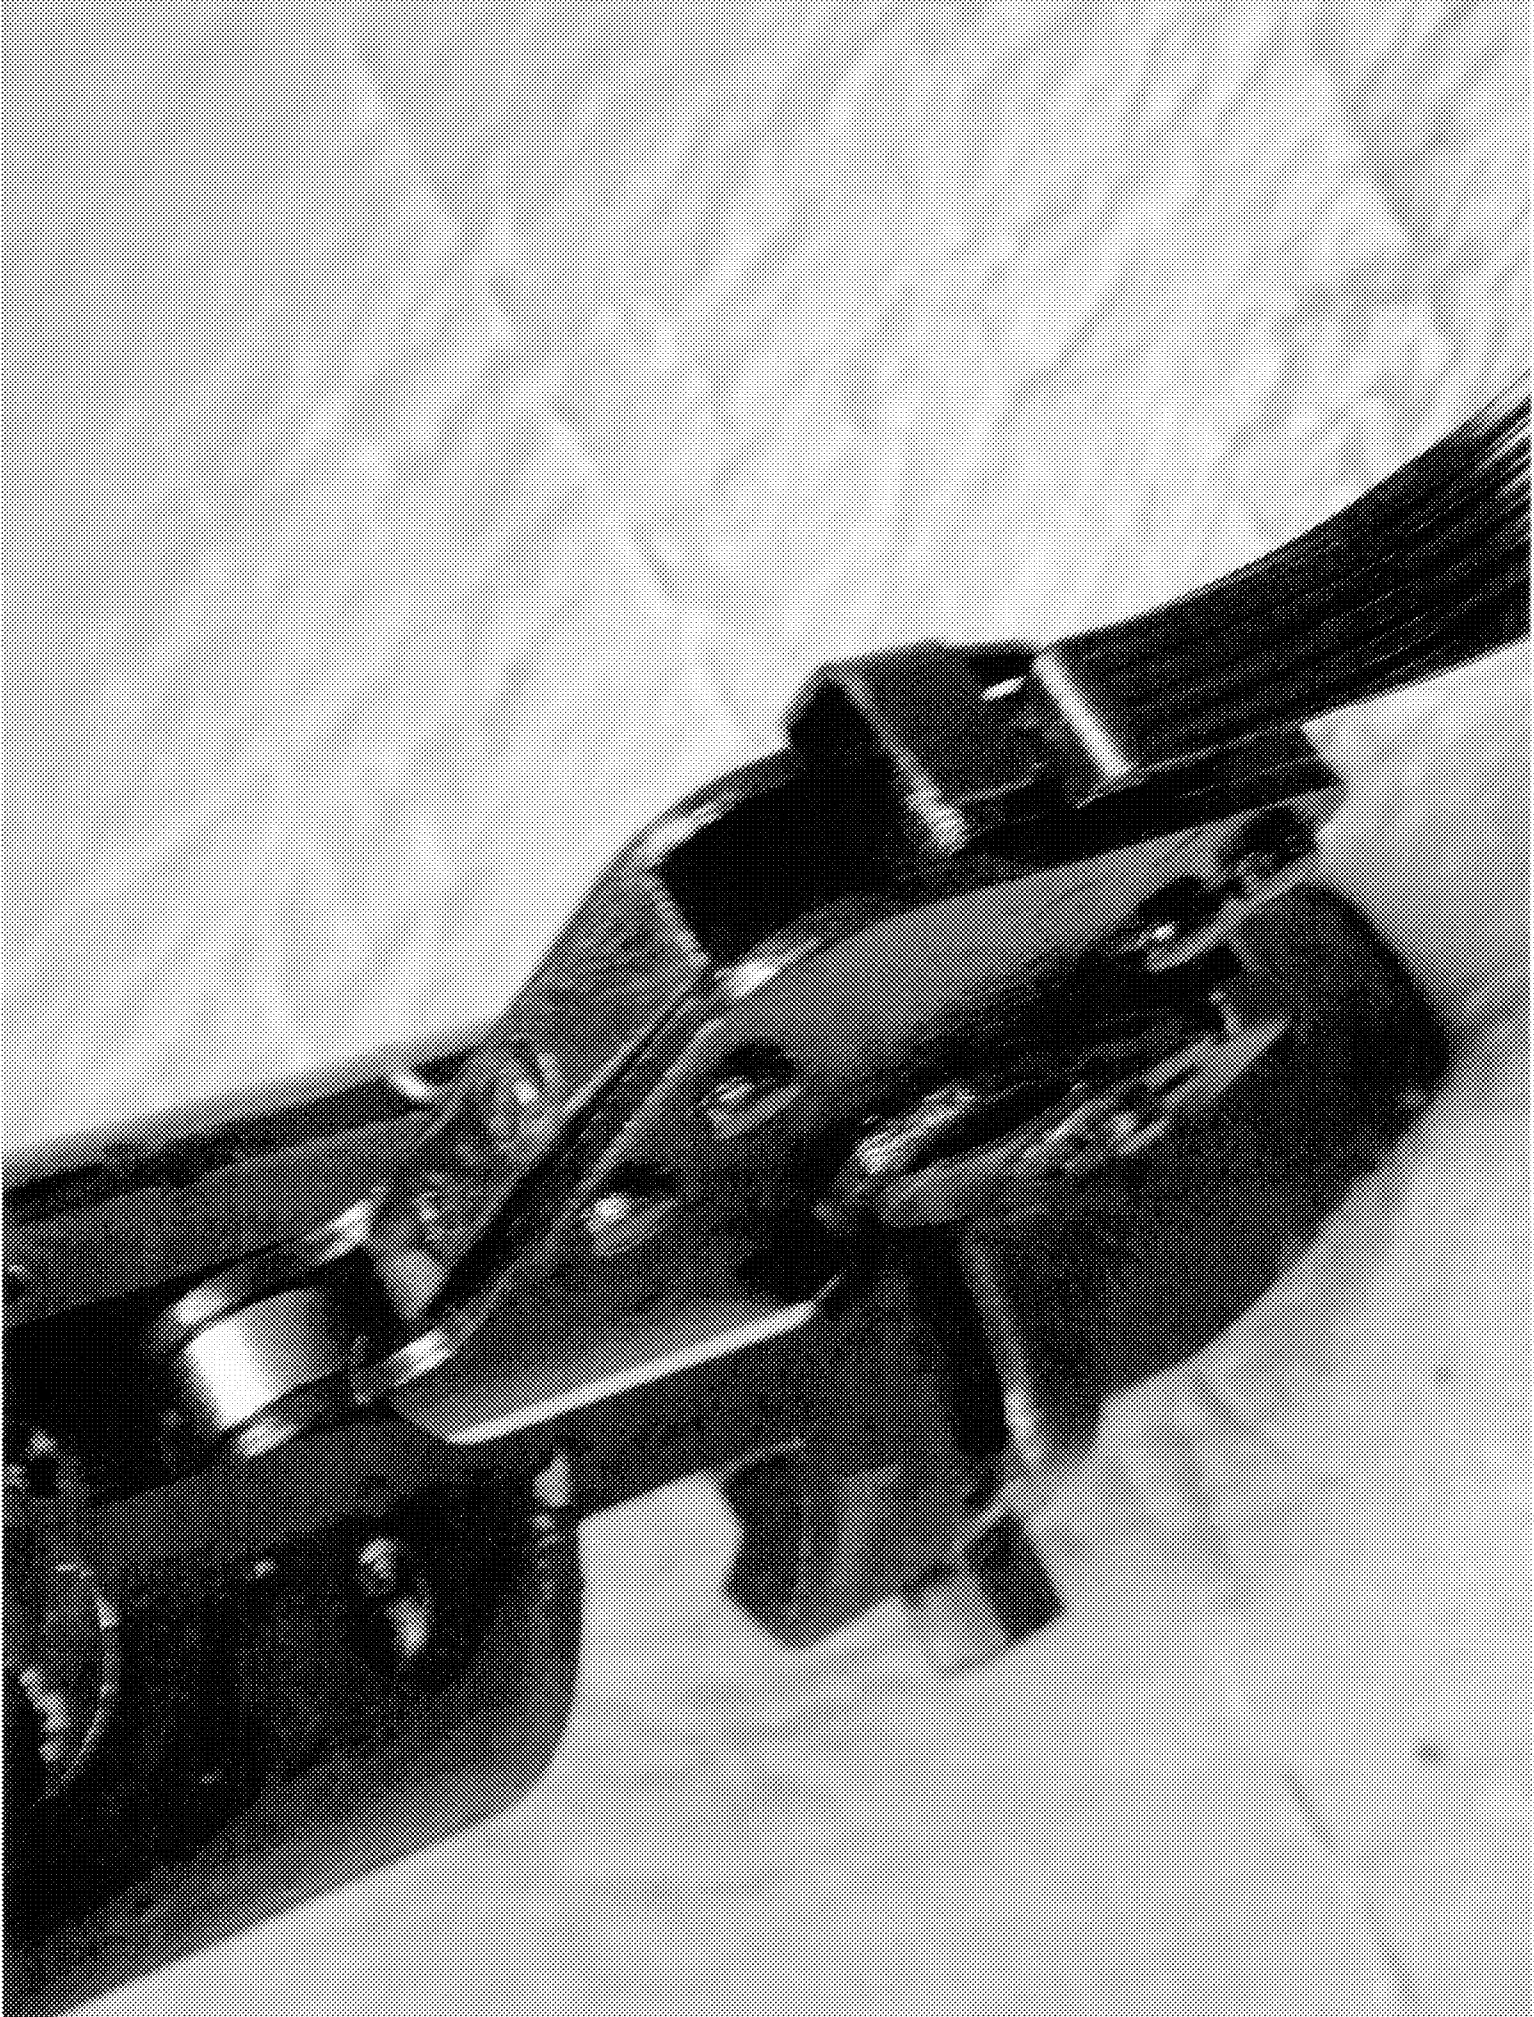
22"  
 PX6/03  
 7.5"  
 1015

4/9/12: Per Ilion - Trigger & pin rusted & causing trigger to bind. Replace TA, clean & test at 1/2 normal cost - quote. Dealer apprvd quote & charged to open account. df
